HENLEYS SECURITY DOORS

EXOVA WARRINGTON BURGLARY RESISTANCE STS202
TESTING DESCRIPTION
INCLUSIVE OF PHOTOGRAPHIC EVIDENCE

INTRODUCTION

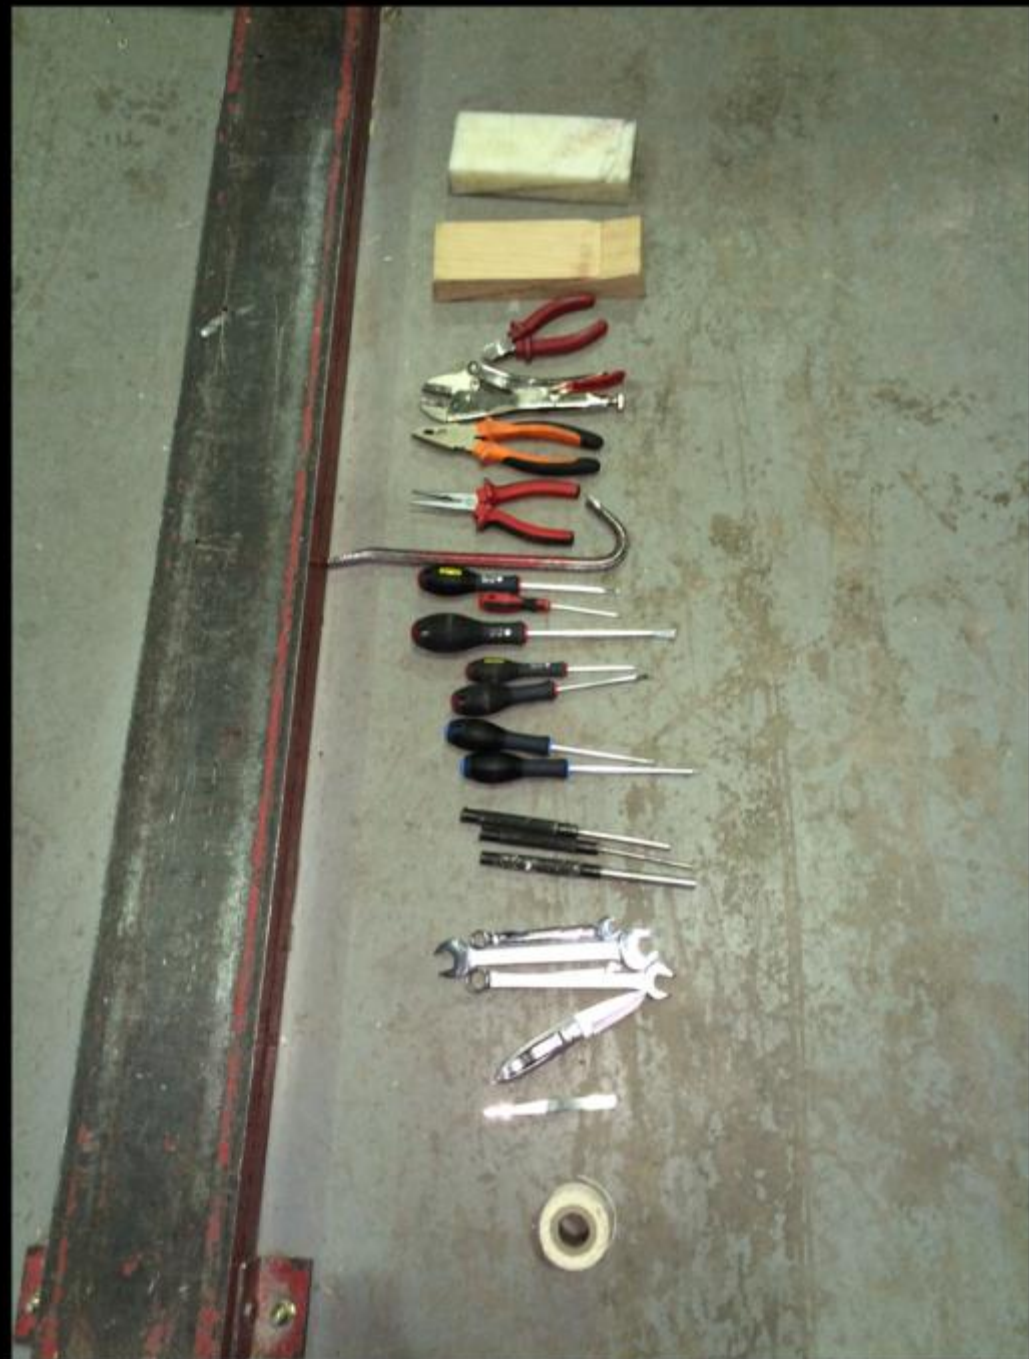
DESCRIPTION OF ALL TOOLS PROVIDED TO THE EXAMINER

Various Sizes of Screwdrivers,
Crowbar, Wedges, Mole Grips, Pliers,
Spanners, Knife, Punches and
Examiners Physical Strength Including
Forceful Kicks and Blows

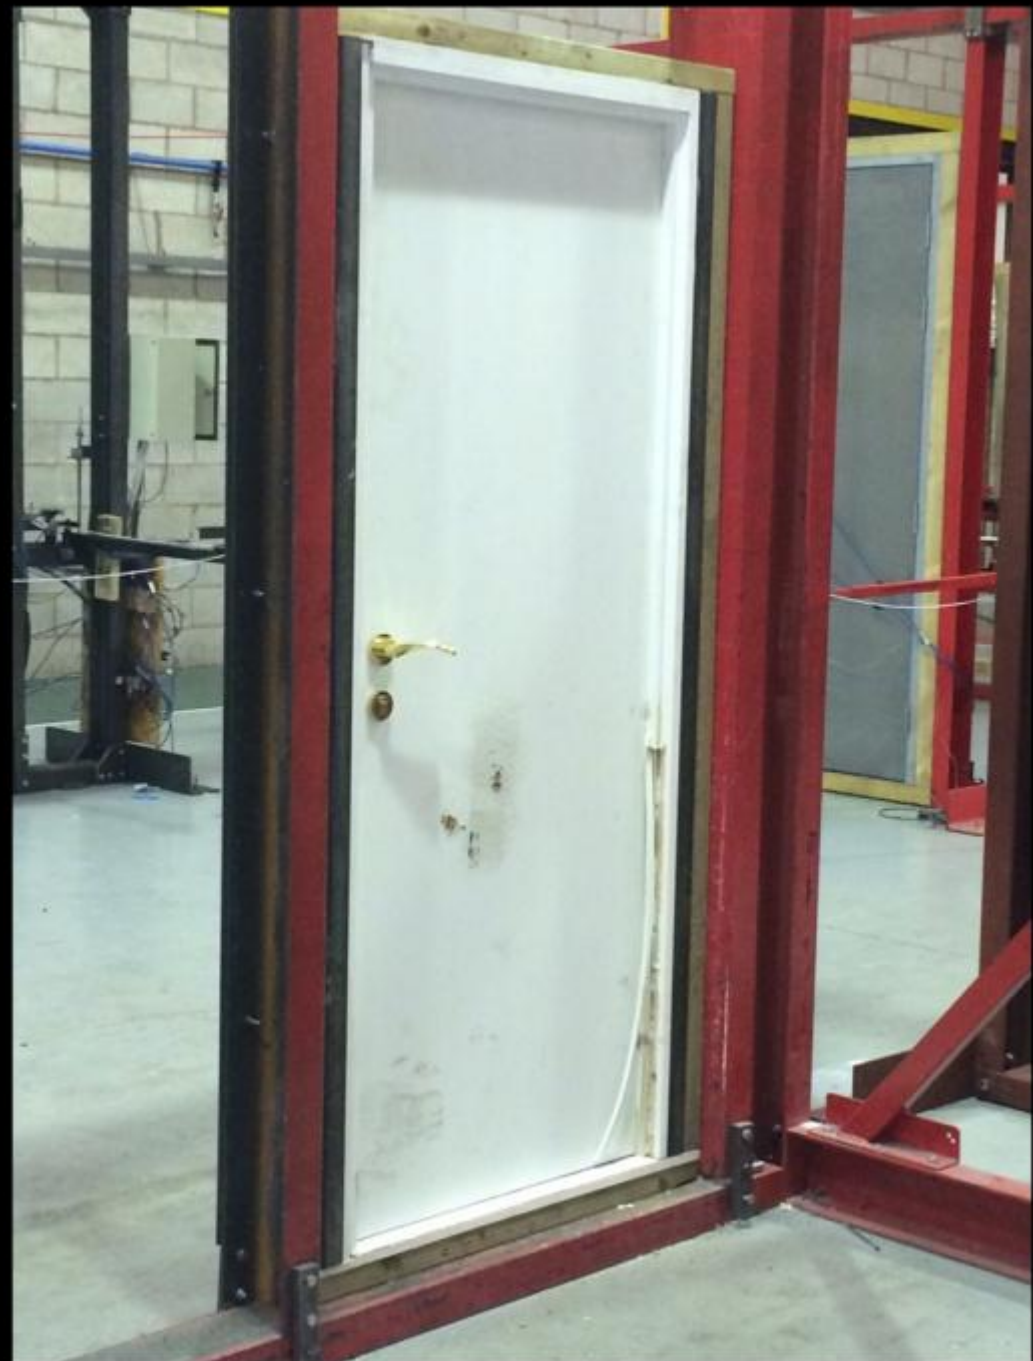
Crowbar Knife and Forceful Kicks

Attack To The Middle Of The Door with Extreme Forward and Backward Kicks. Attack To The Lower Right Of The Door With The Use of A Crowbar. Attack To The Middle of The Door With The Use of A Sharp Knife (As Shown).

Minor Damage To External Face and Slam Strip.
NO ACCESS GAINED. PASS

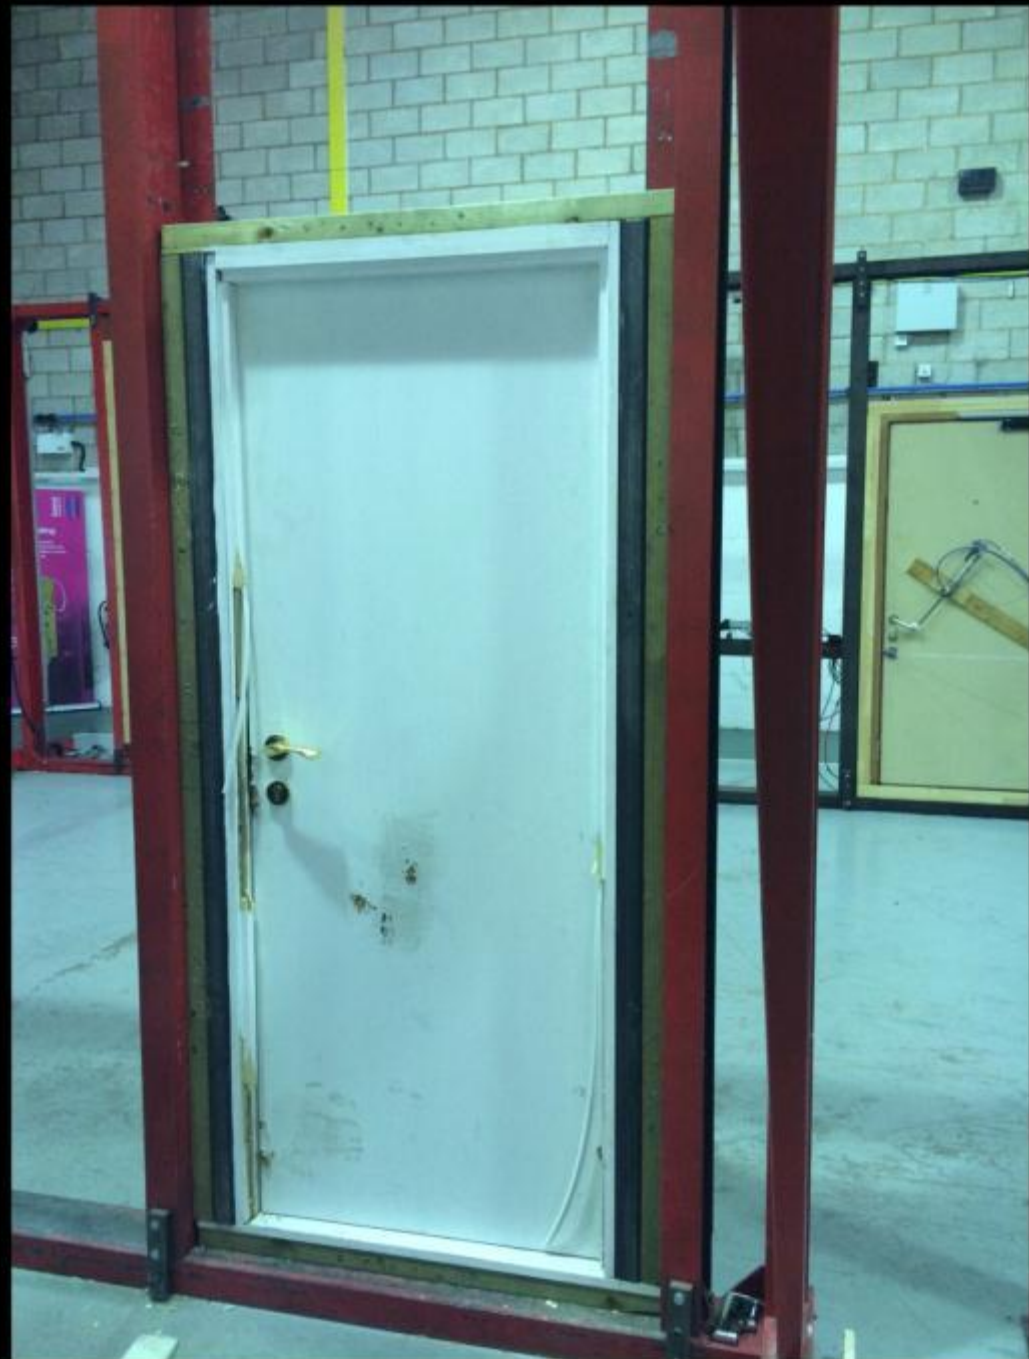
Crowbar

Attack To The Lower Left of The Door With The
Use of A Crowbar (As Shown)

Minor Damage To External Face.
NO ACCESS GAINED. PASS

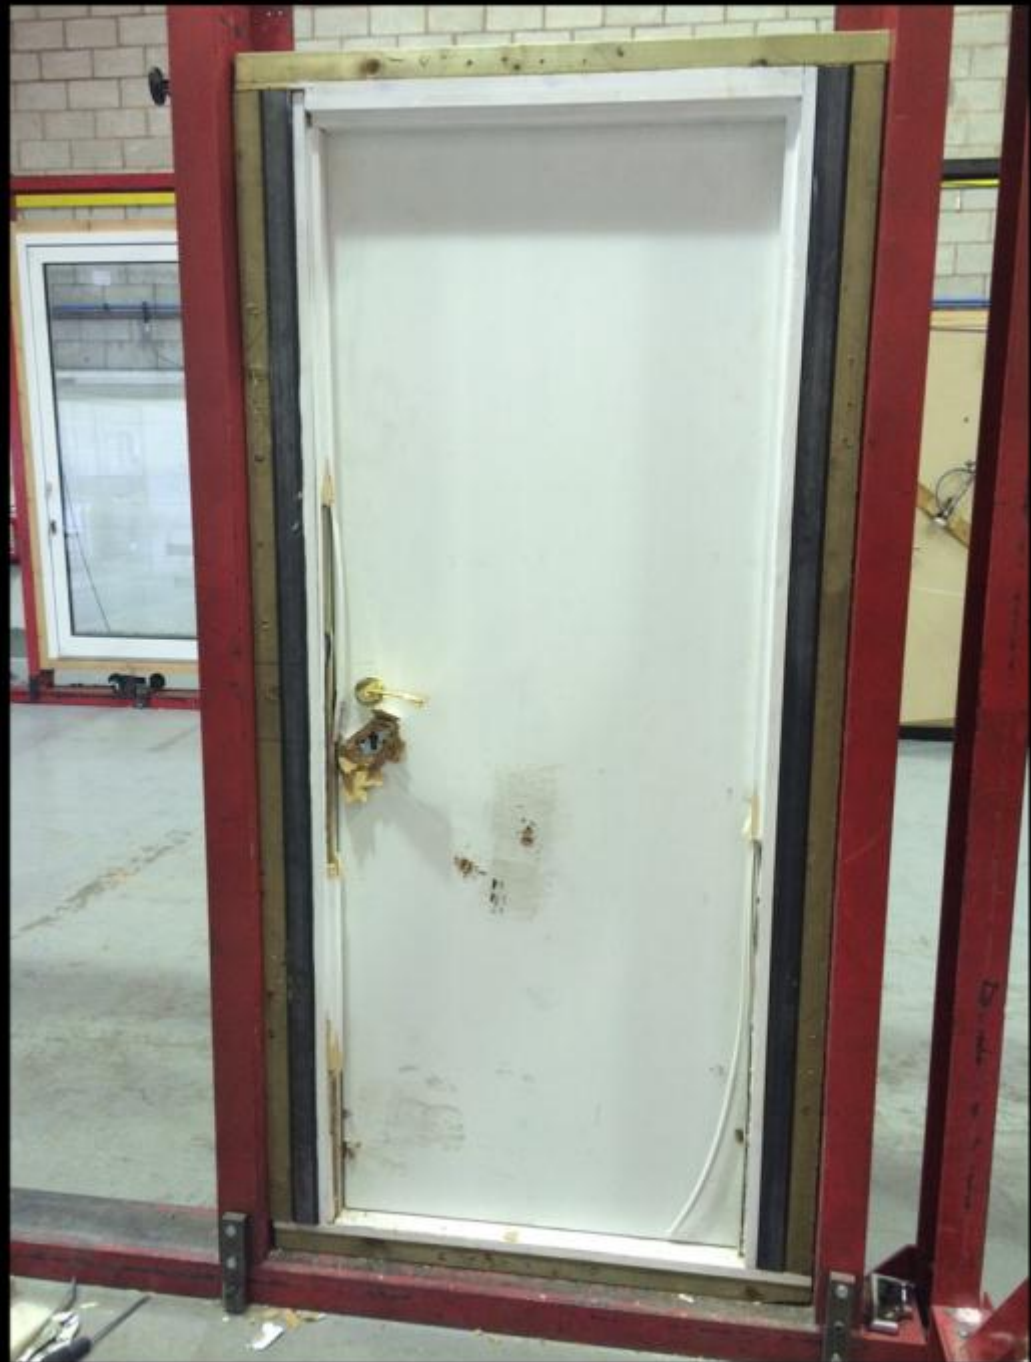
Crowbar and Screwdriver

Attack To The Lower Left Of The Door With The Use Of A Crowbar. Attack To The Escutcheon With the Use Of A Crowbar and Screwdriver (As Shown)

Minor Damage To External Face. Escutcheon Removed.
NO ACCESS GAINED. PASS

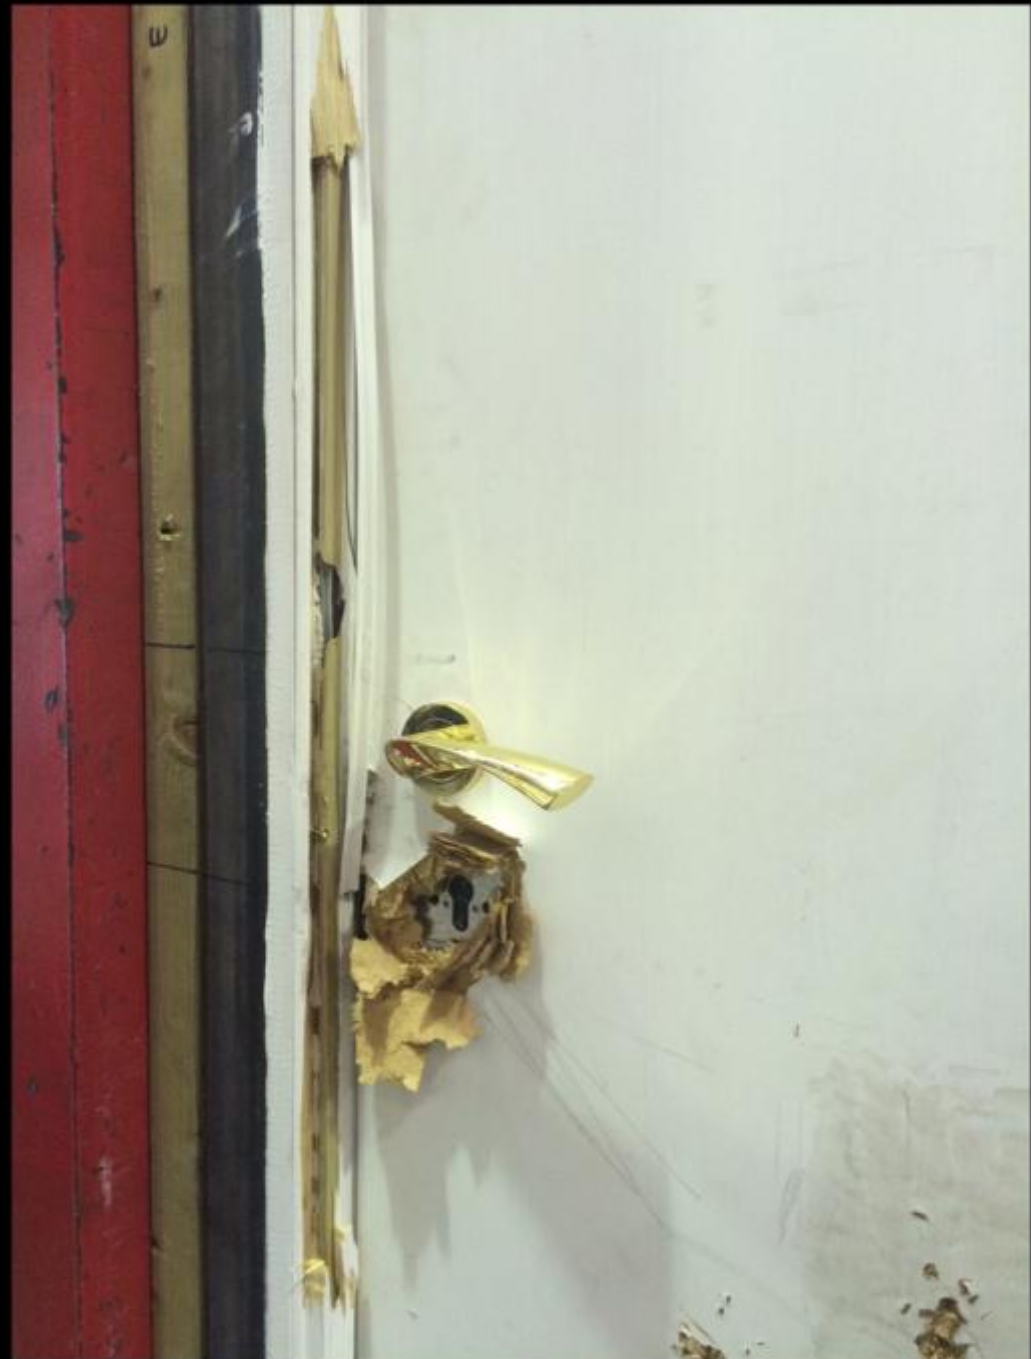
Attack To The Lock Region Of The Door With The
Use of A Crowbar.

Minor Damage To External Face.
NO ACCESS GAINED. PASS

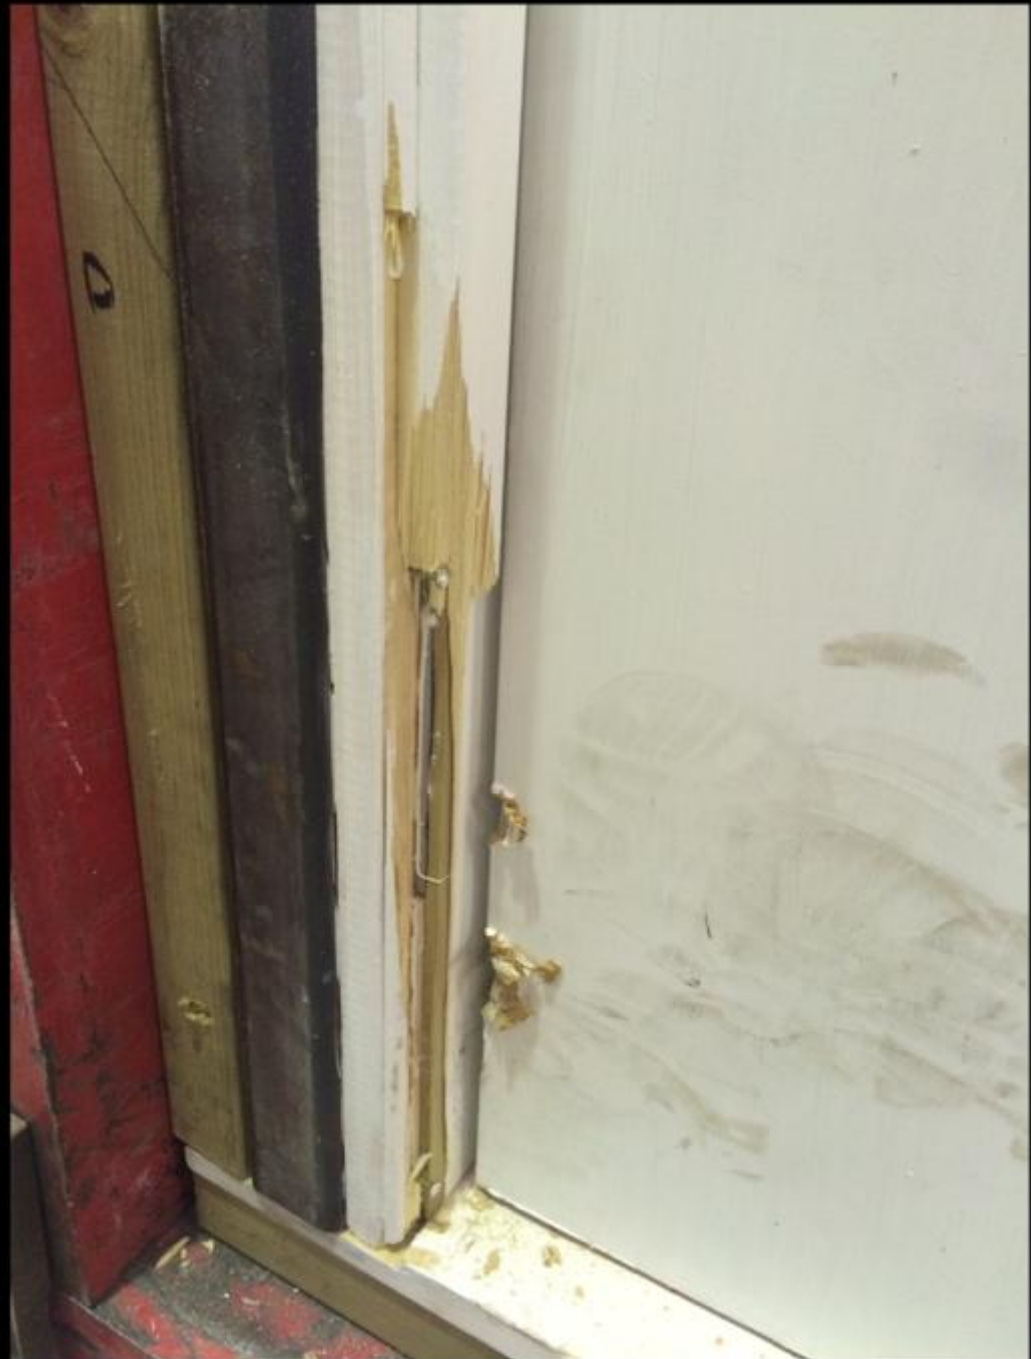
Attack To The Lower Left Of The Door With The
Use of A Crowbar

Minor Damage To External Face and Door Frame.
NO ACCESS GAINED. PASS

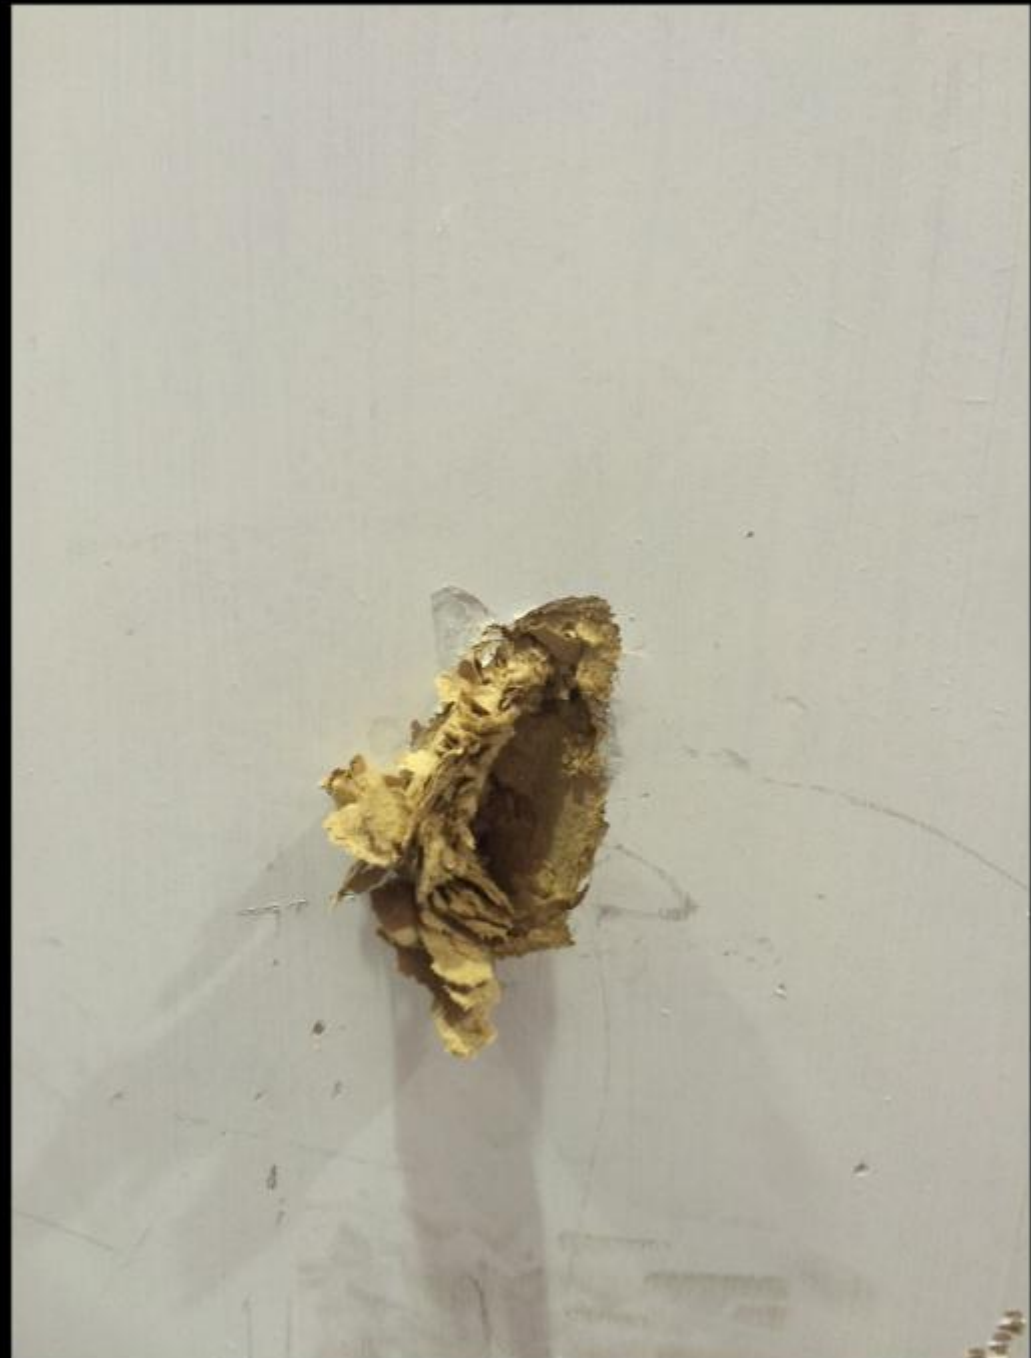
Attack To The Middle of The Door With The Use
Of a Drill.

Damage To External Face.
NO ACCESS GAINED. PASS

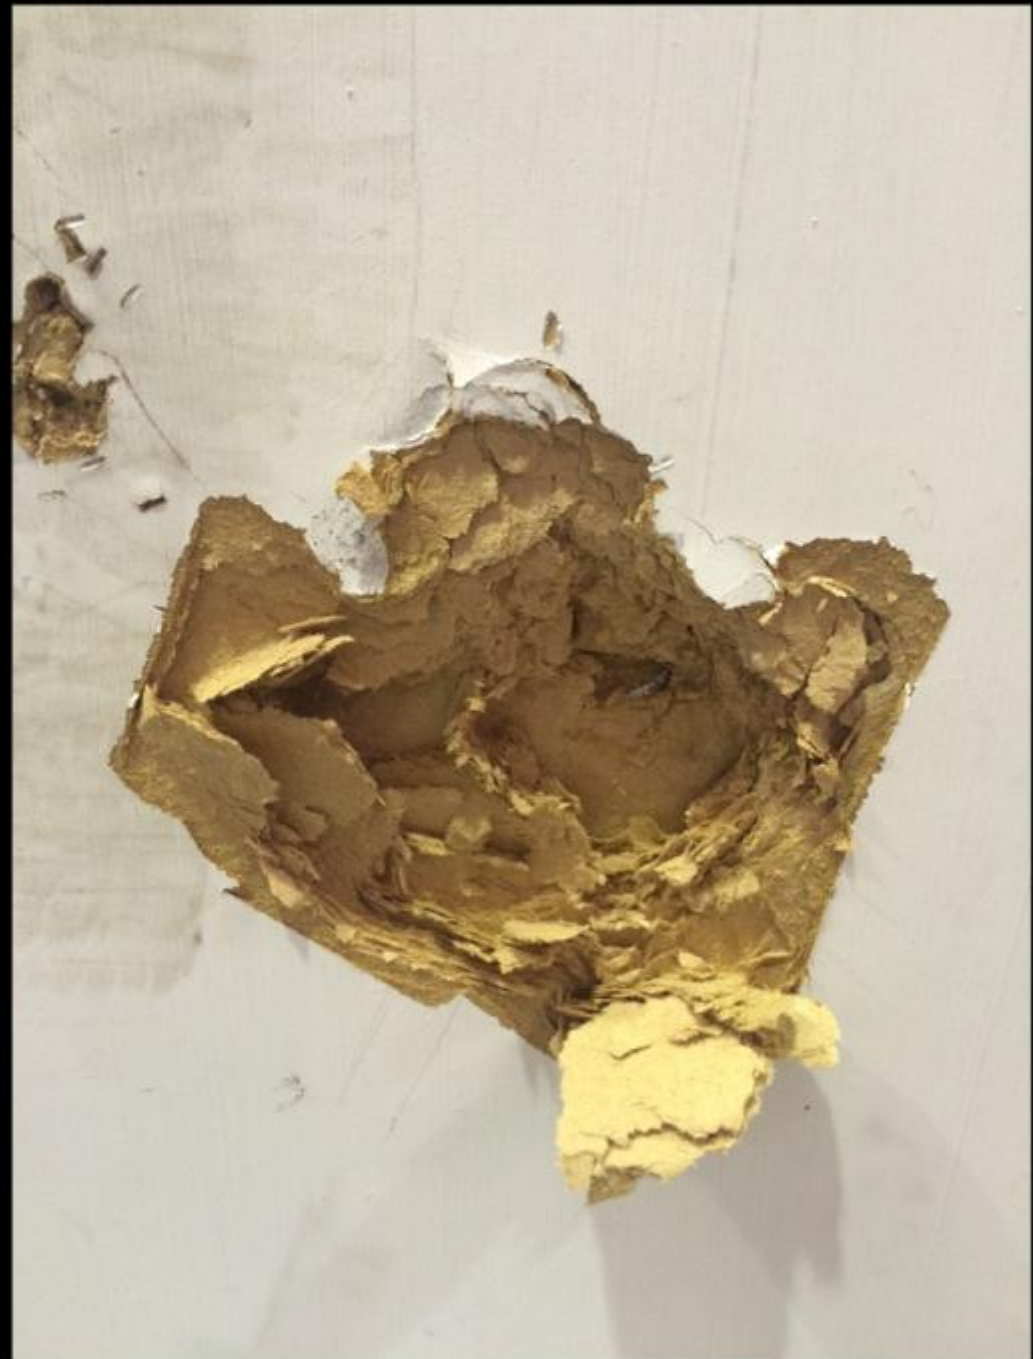
Attack To The Middle of The Door With The Use
Of a Drill, A Hammer, Screwdriver and A
Crowbar

Damage To External Face.
NO ACCESS GAINED. PASS

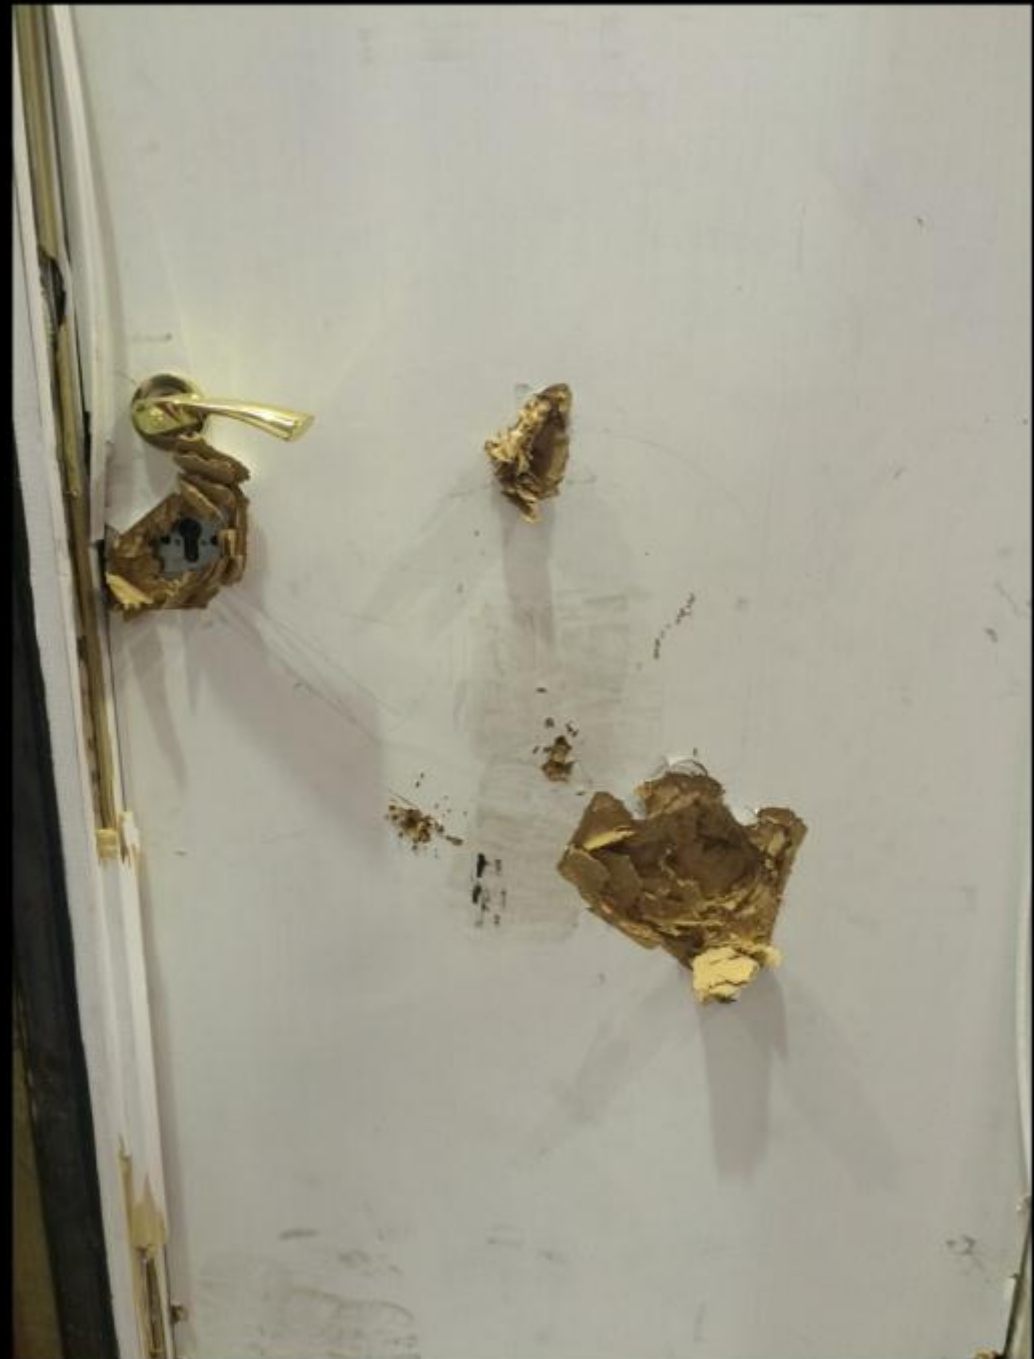
Attack To The Middle of The Door With The Use Of A Hammer and Chisel to Further Penetrate The Previously Made Hole. Attack To The Middle of The Door With A Hammer Landing Heavy Blows. A Fresh Examiner Takes Over and The Above Attack Process is Repeated.

Damage To External Face.
NO ACCESS GAINED. PASS

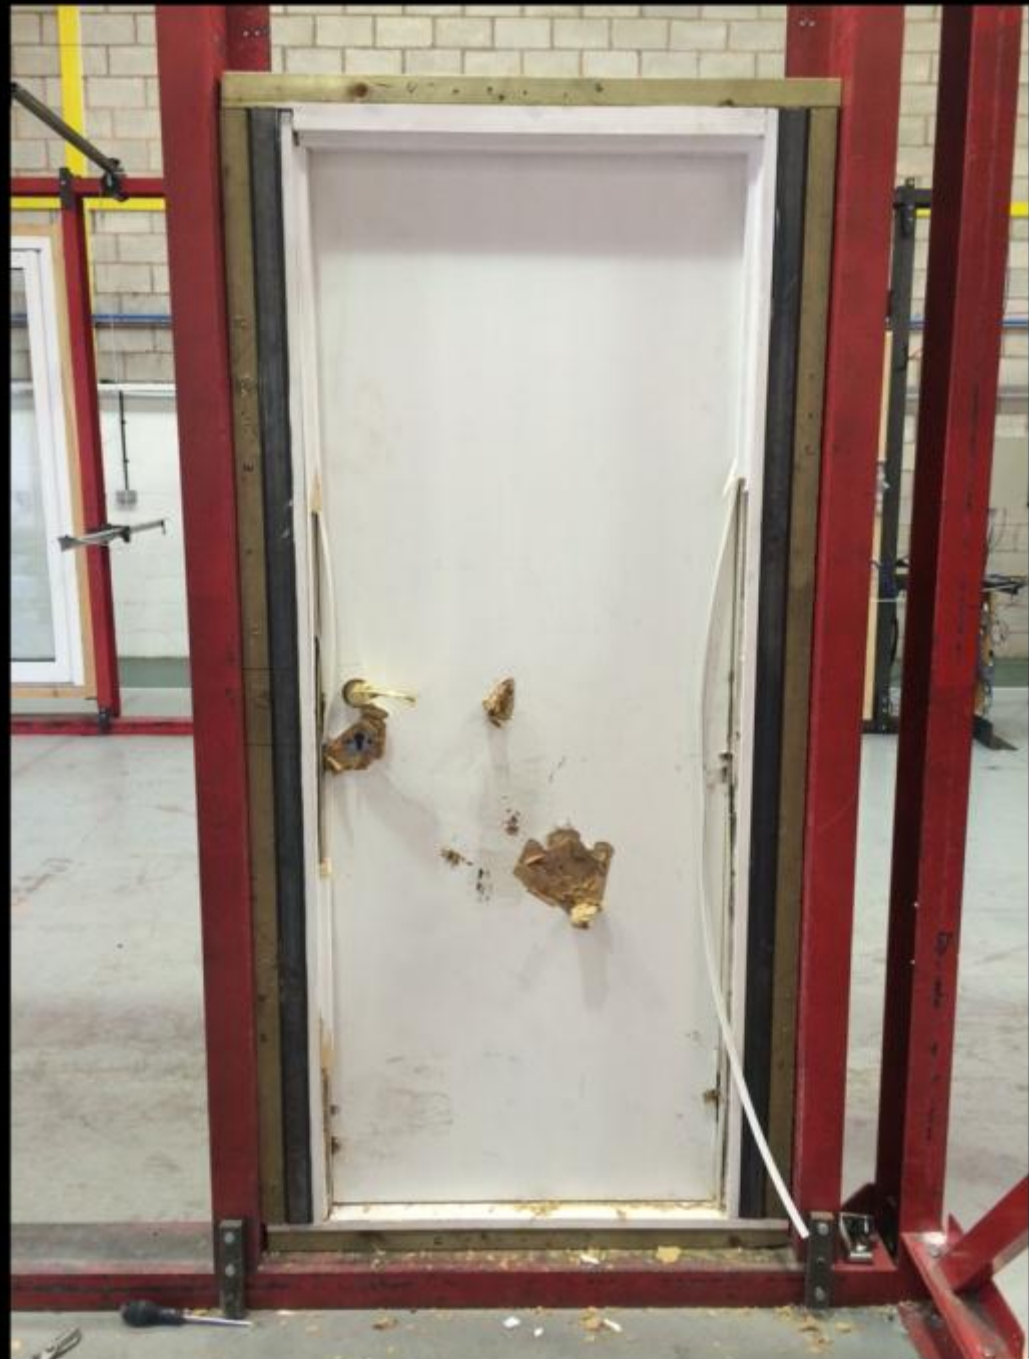
Attack To The Door With The Use Of A Manual Drill. Attack To The Lower Middle of The Door With The Use Of An 18v- Battery Powered Drill, Crowbar and Hammer. Attack To The Lock Region With The Use of A Crowbar and Hammer. Attack To The Middle Left Around The Lock Area With The Use of A Crowbar. Attack To The Lower Left Slam Strip With The Use of A Crowbar. Attack To The Lower Right Hinge With The Use of A Crowbar.

Minor Damage To External Face and Door Frame.
NO ACCESS GAINED. PASS

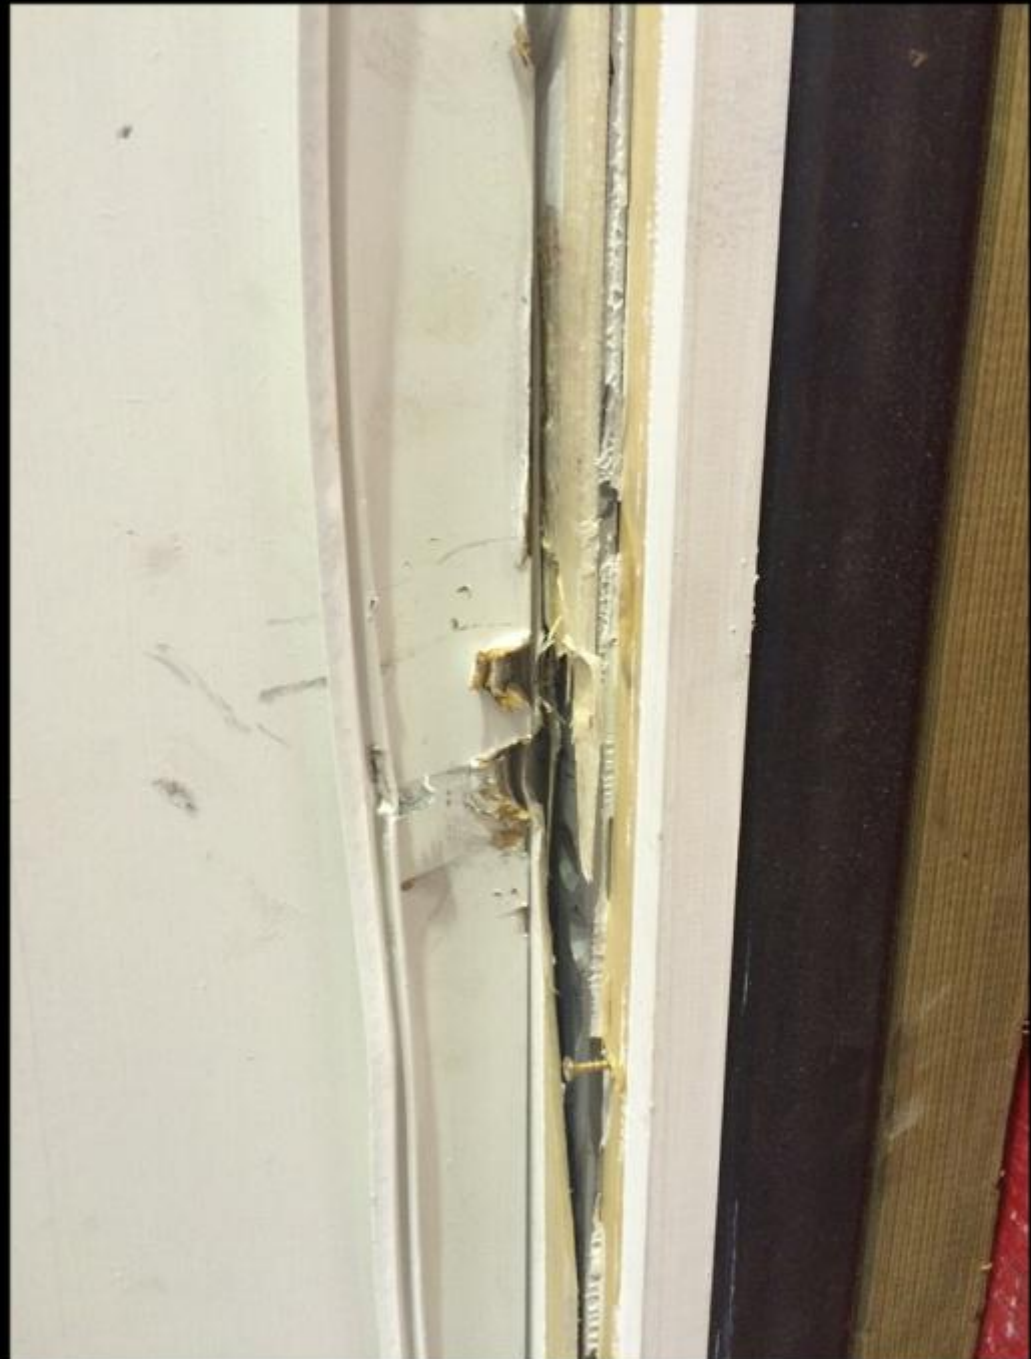
Attack To The Lower Right Hinge With The Use of
A Crowbar, Wedges and Screwdriver.

Damage To External Face and Door Frame.
NO ACCESS GAINED. PASS

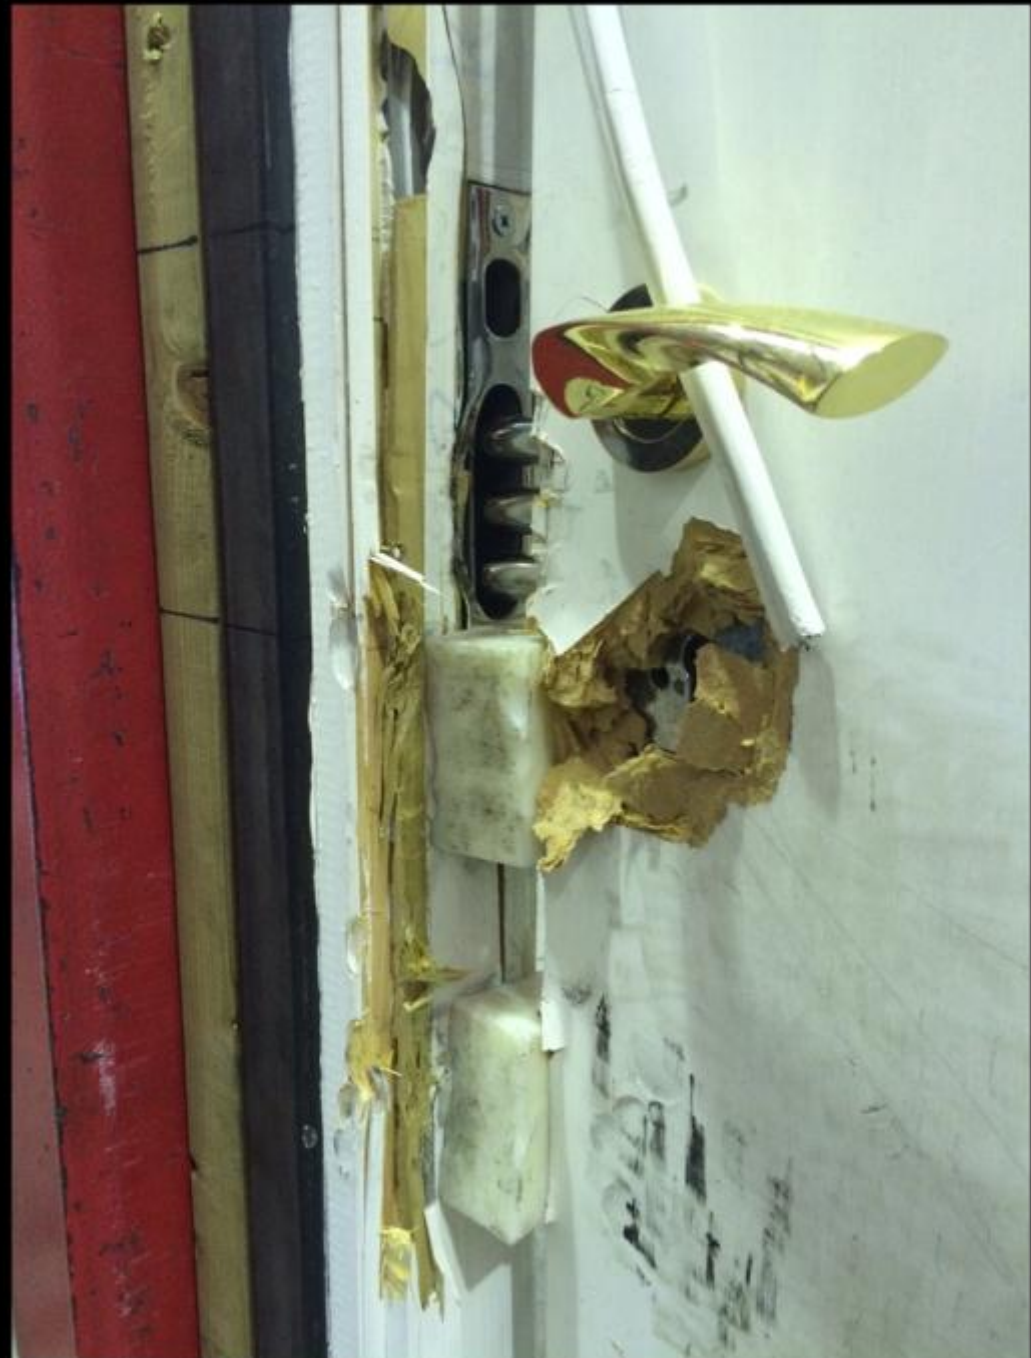
Attack To The Lock Region With The Use Of A
Hammer, Wedges (As Shown) and A Series of
Forceful Front Kicks For A Sustained Amount of
Time. The Above Attack Process is Repeated
Several Times

Damage To External Face and Door Frame.
NO ACCESS GAINED. PASS

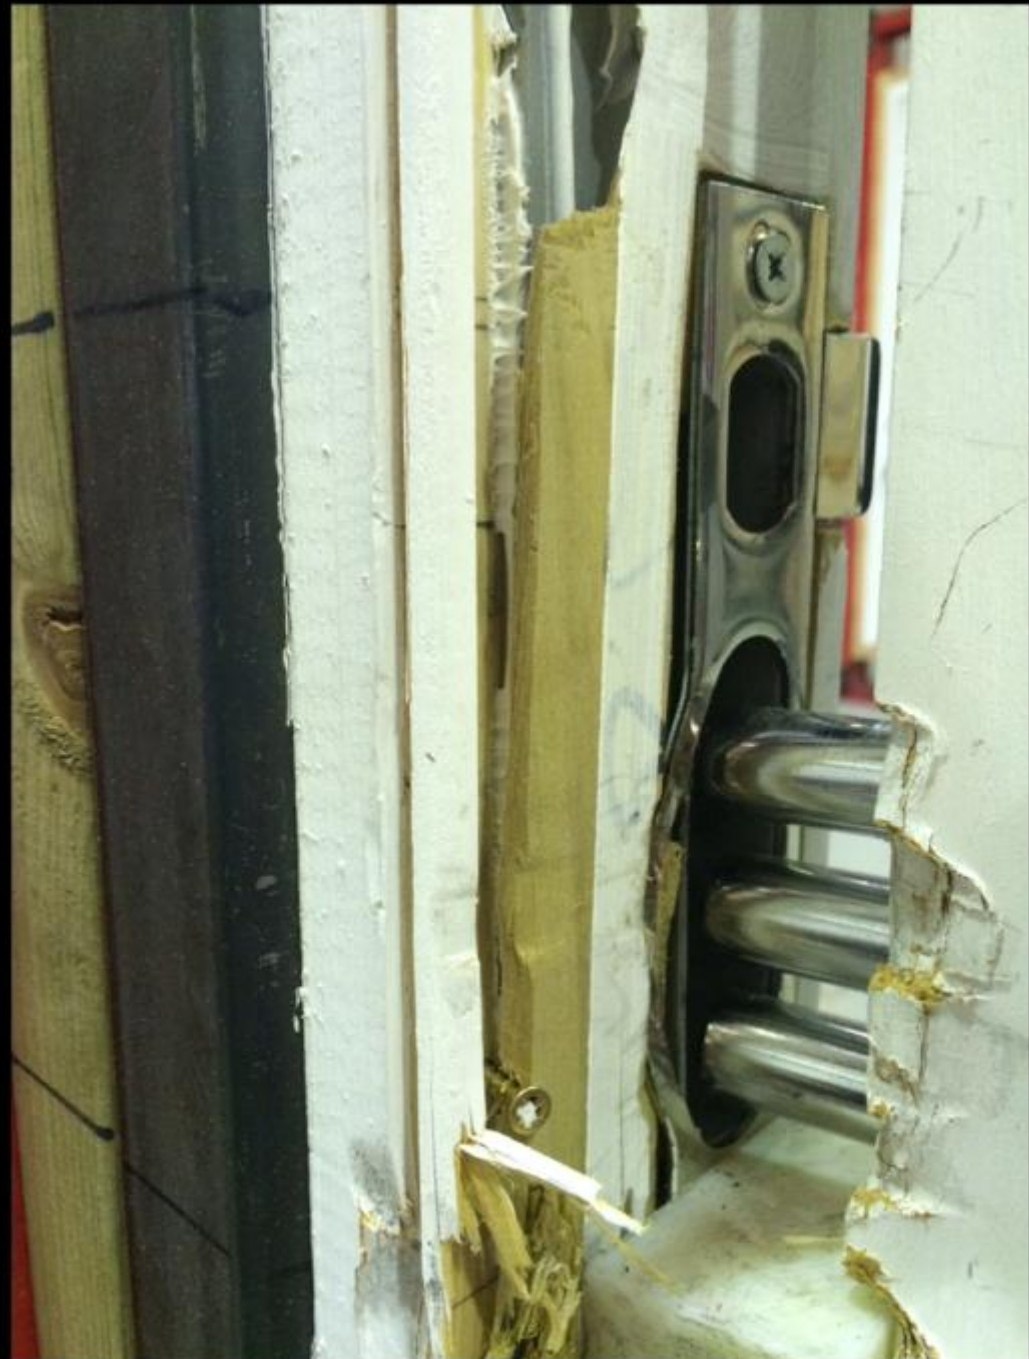
Damage To External Face.
NO ACCESS GAINED. PASS

CLOSE UP IMAGE
OF ATTACK TO LOCK REGION

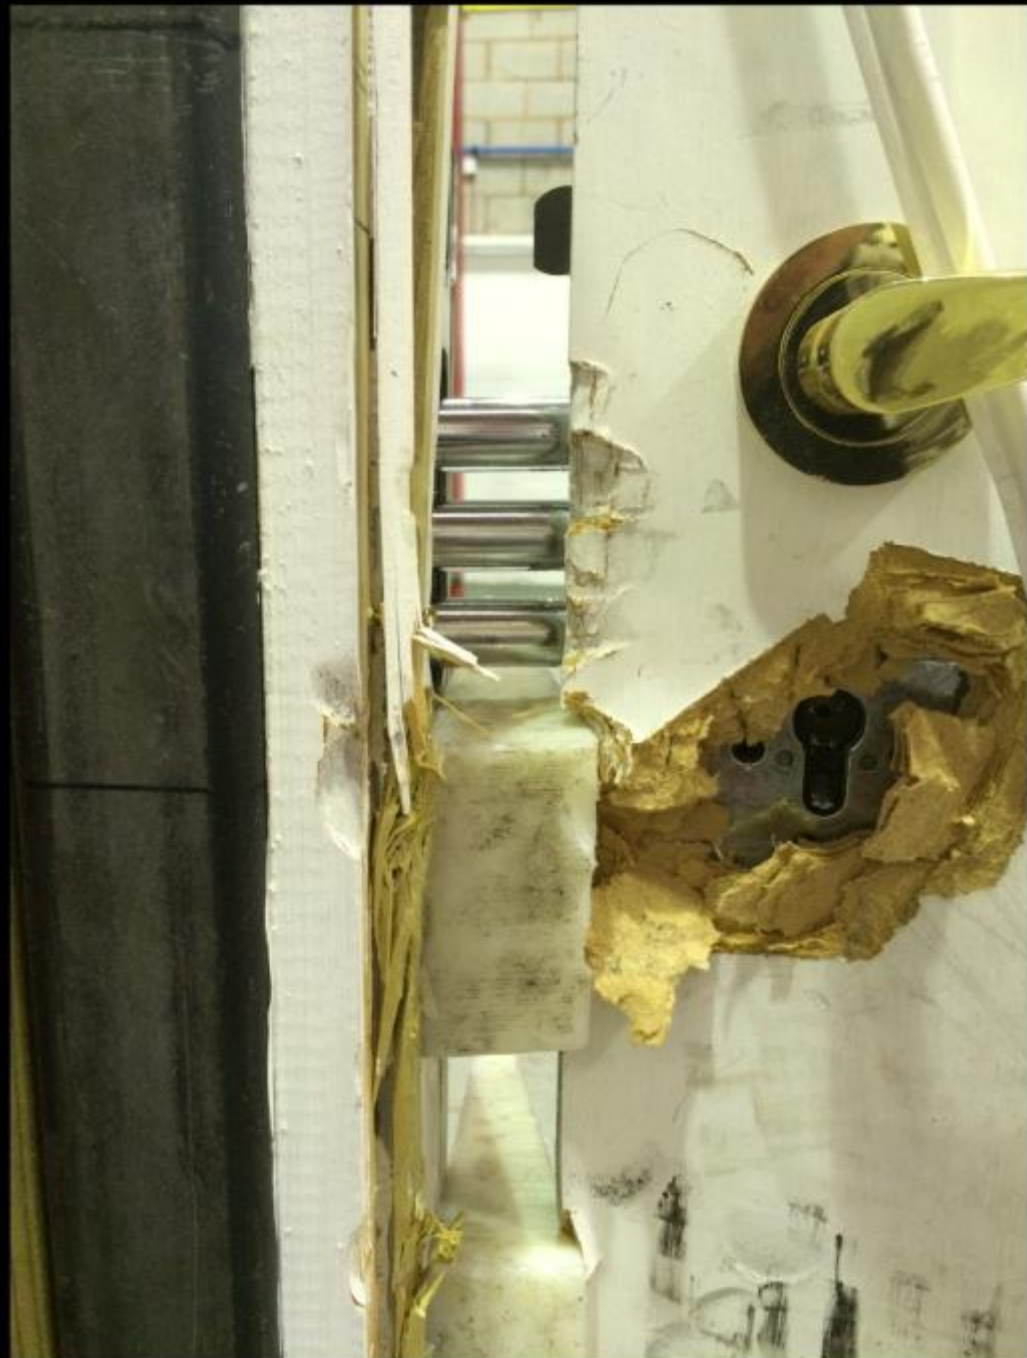
Damage To External Face.
NO ACCESS GAINED. PASS

CLOSE UP IMAGE
OF ATTACK TO LOCK REGION

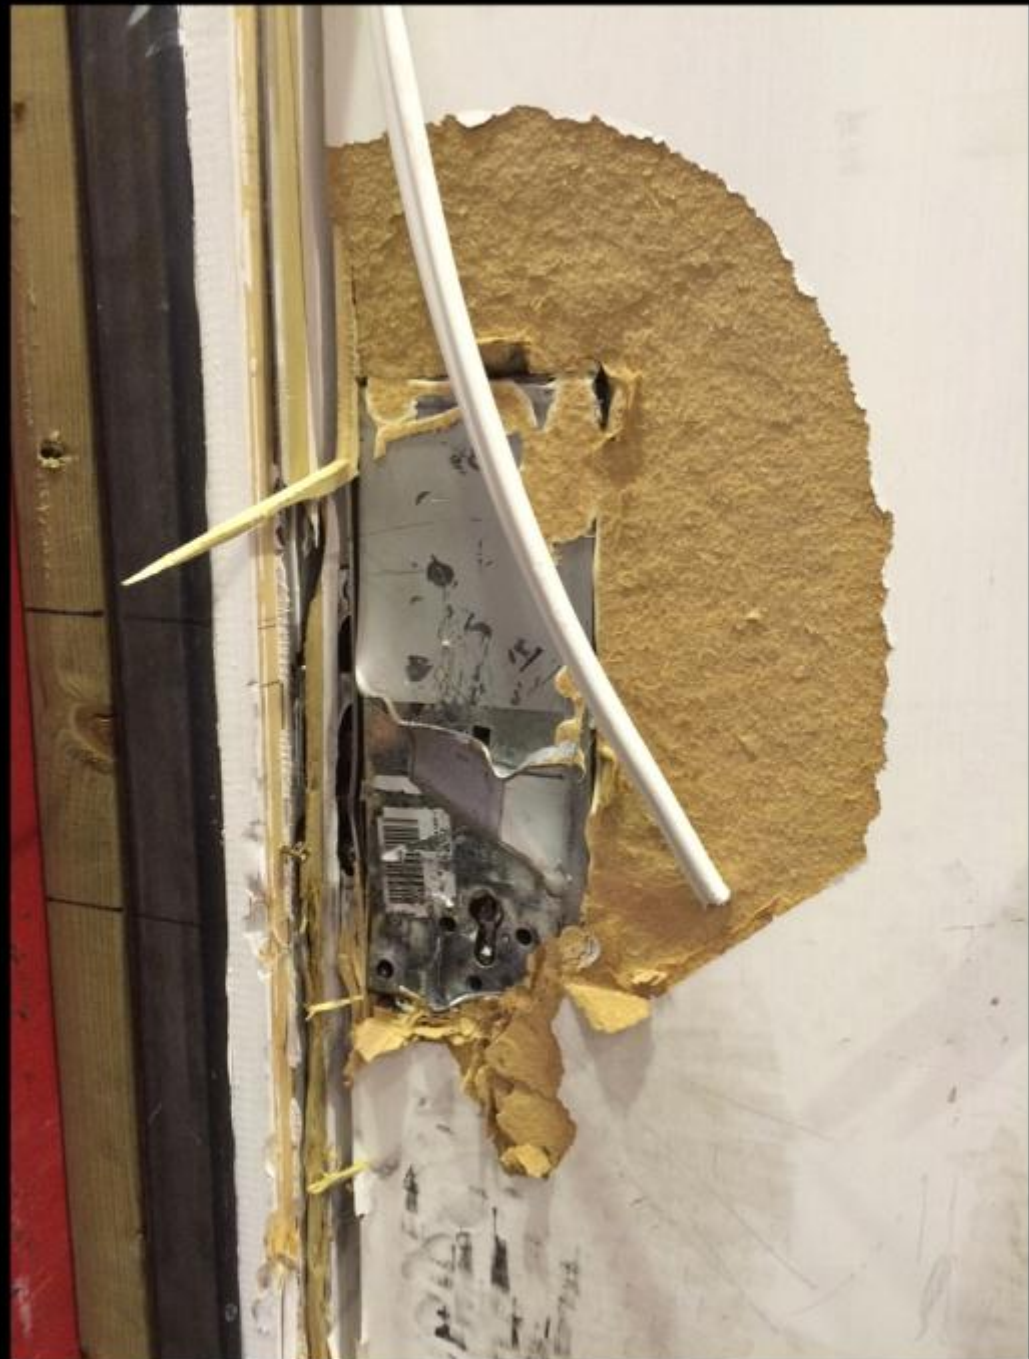
Attack To The Lock Region and Door Handle With
The Use of A Hammer, Crowbar and Mole Grips.
Forceful Downward Blows With The Hammer.
Pulling and Prising action With The Crowbar.
Pulling and Bending Action With The Mole Grips.

Door Handle Removed. Damage To External Face
and Damage to Outer Lock Plate.
NO ACCESS GAINED. PASS

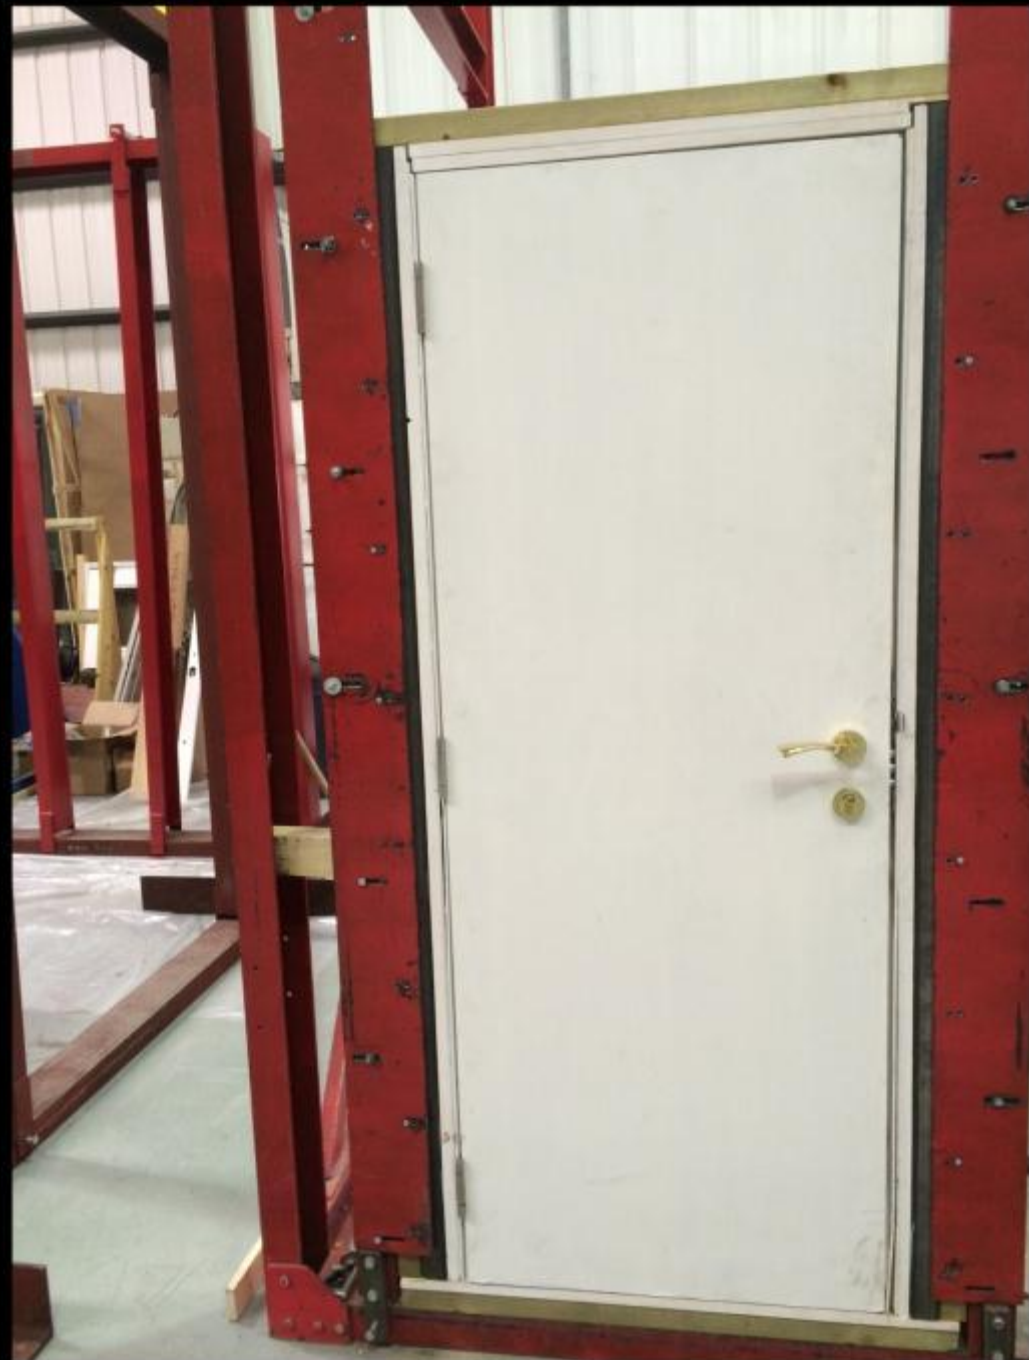
Image Showing No Damage To
The Inside Face of The Door
Having Been Attacked From
The Outer Face, Displayed On
Previous Slide
