HENLEYS SECURITY DOORS

EXOVA WARRINGTON BURGLARY RESISTANCE STS202
TESTING DESCRIPTION
INCLUSIVE OF PHOTOGRAPHIC EVIDENCE

INTRODUCTION

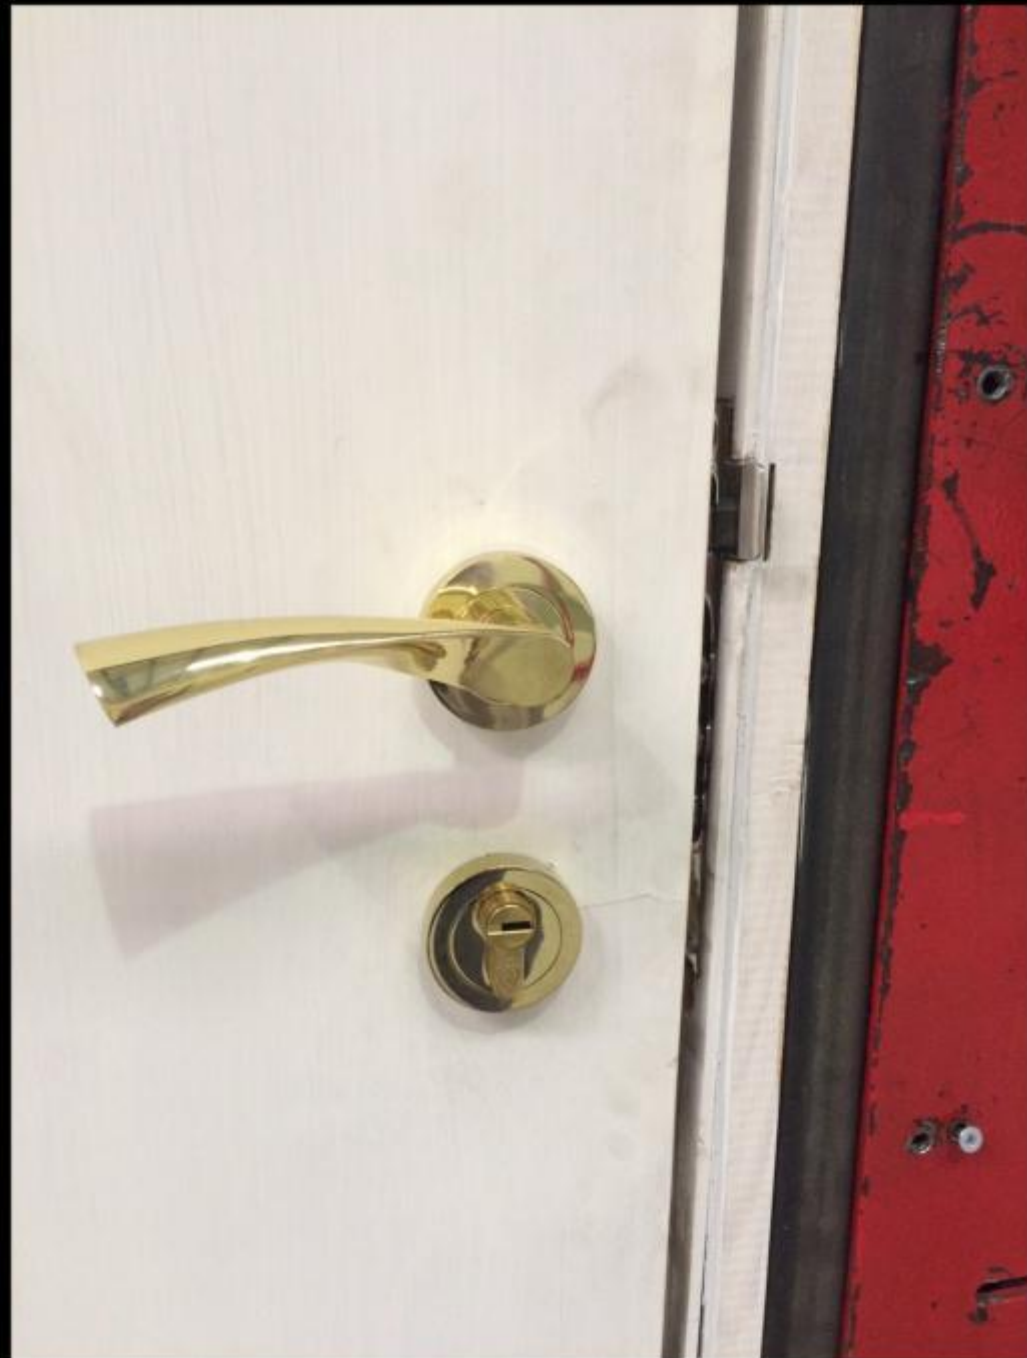
Image Showing No Damage
To The Inside Face of The
Door, Door Handle and Door
Lock Having Been Attacked
From The Outer Face

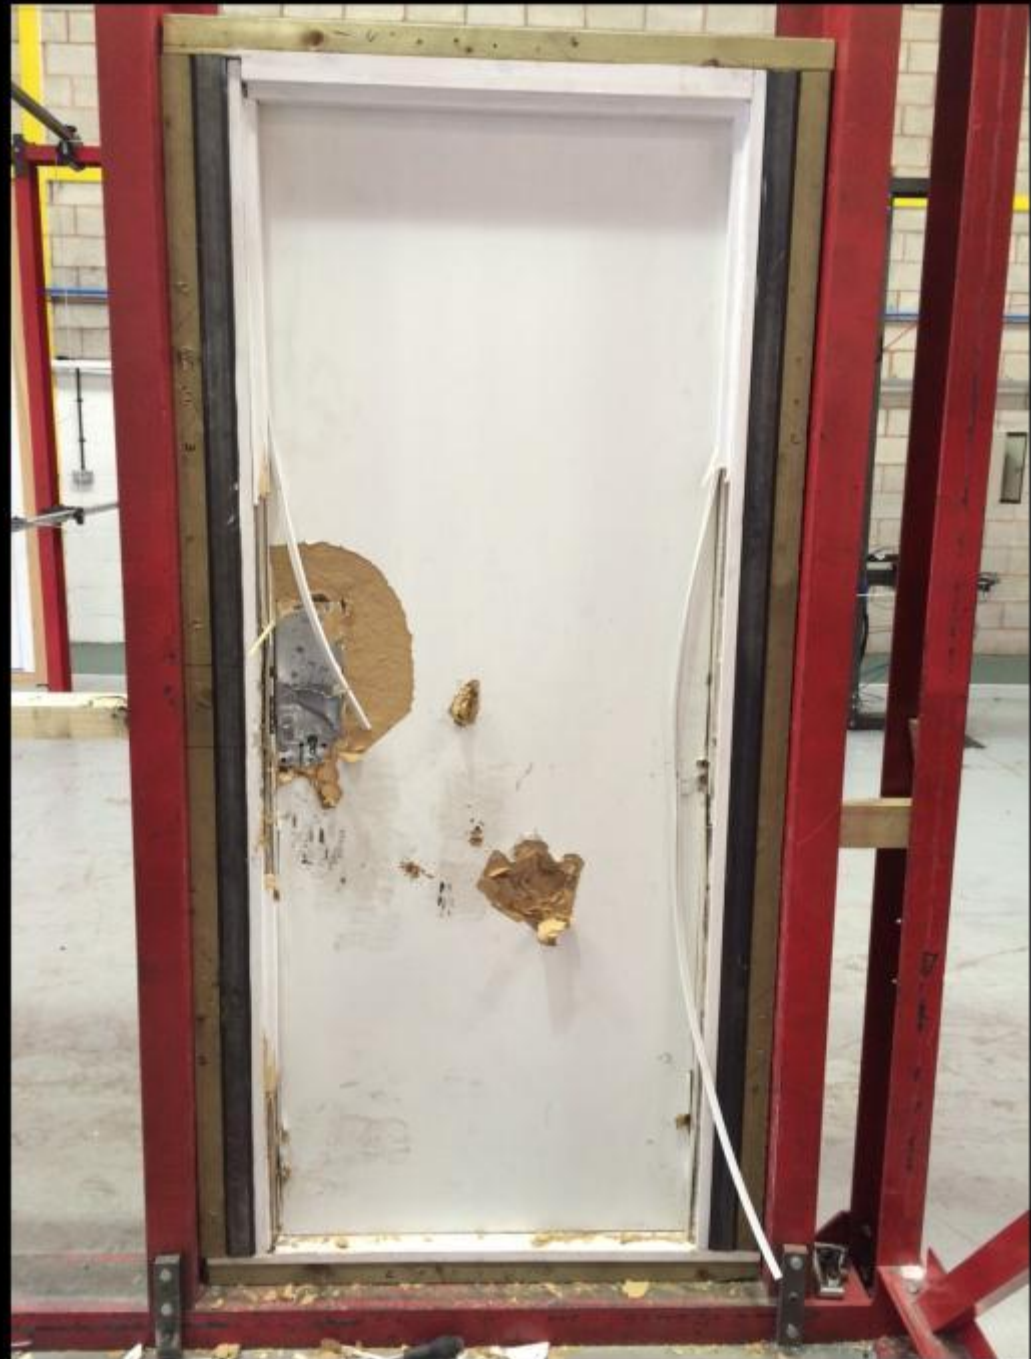
At This Stage, The Door Has Withstood A Series of Specifically Targeted Attacks For A Period of time Totalling 28 Minutes and Still Remains Un-penetrated

Image Showing The Door Having Minimal Resulting Damage

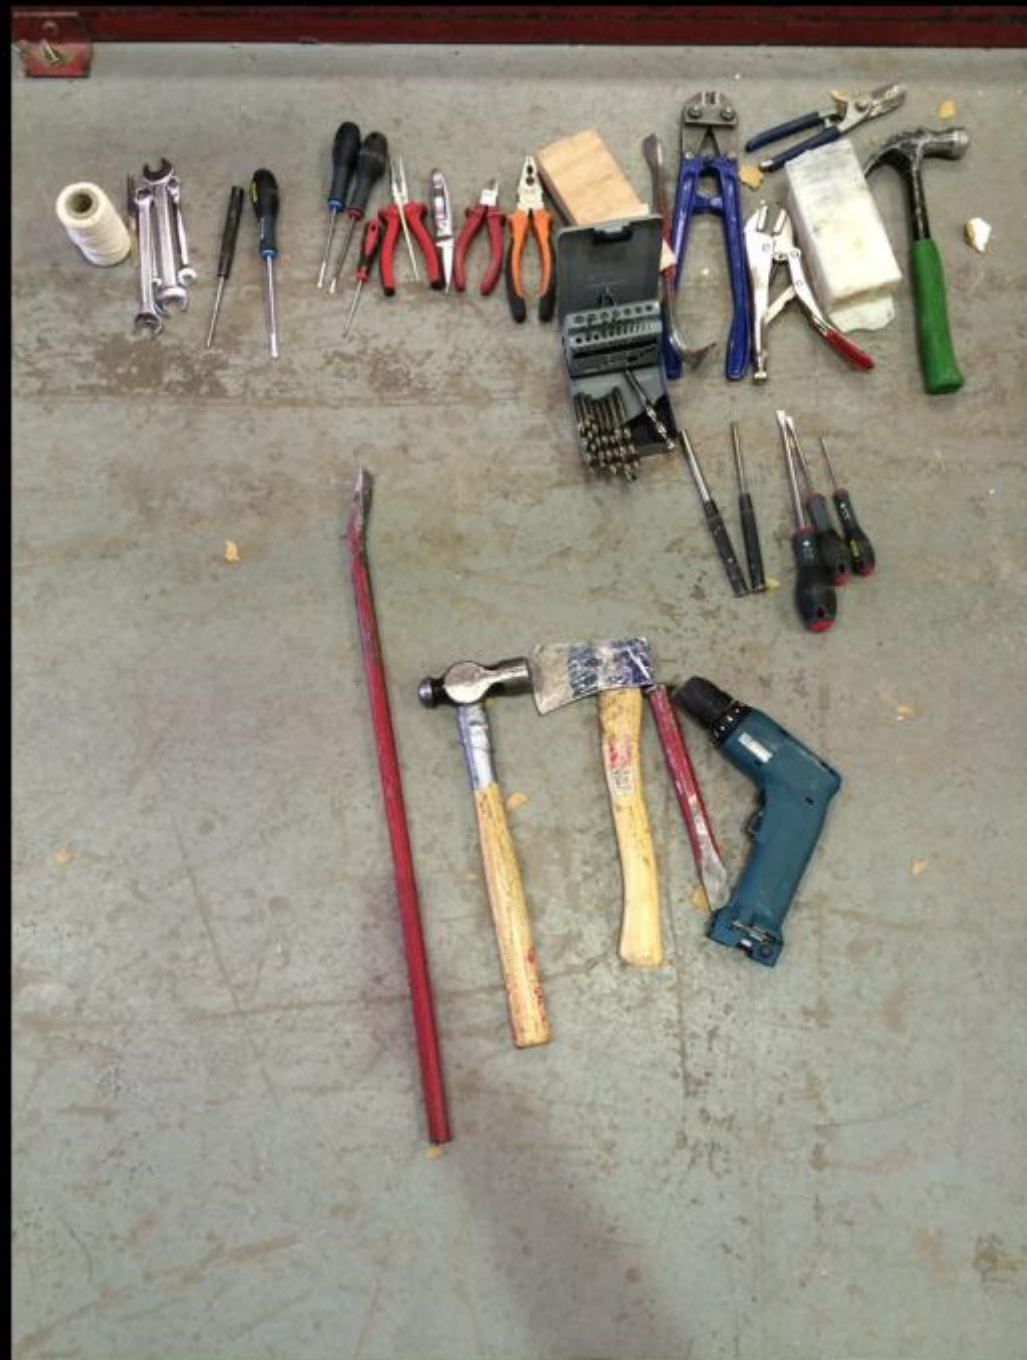
DESCRIPTION OF ALL TOOLS PROVIDED TO THE EXAMINER

Various Sizes of Spanners, Lock Picking Tool, Various Sizes of Screwdrivers, Thin Nose Pliers, Knife, Pliers, Wedges, Mole Grips, Large Hammer, 18v-Battery Powered Drill and Drill Bits, Cold Chisel, Bolt Cutters, Axe, Large Crowbar and Examiners Physical Strength Including Forceful Kicks and Blows

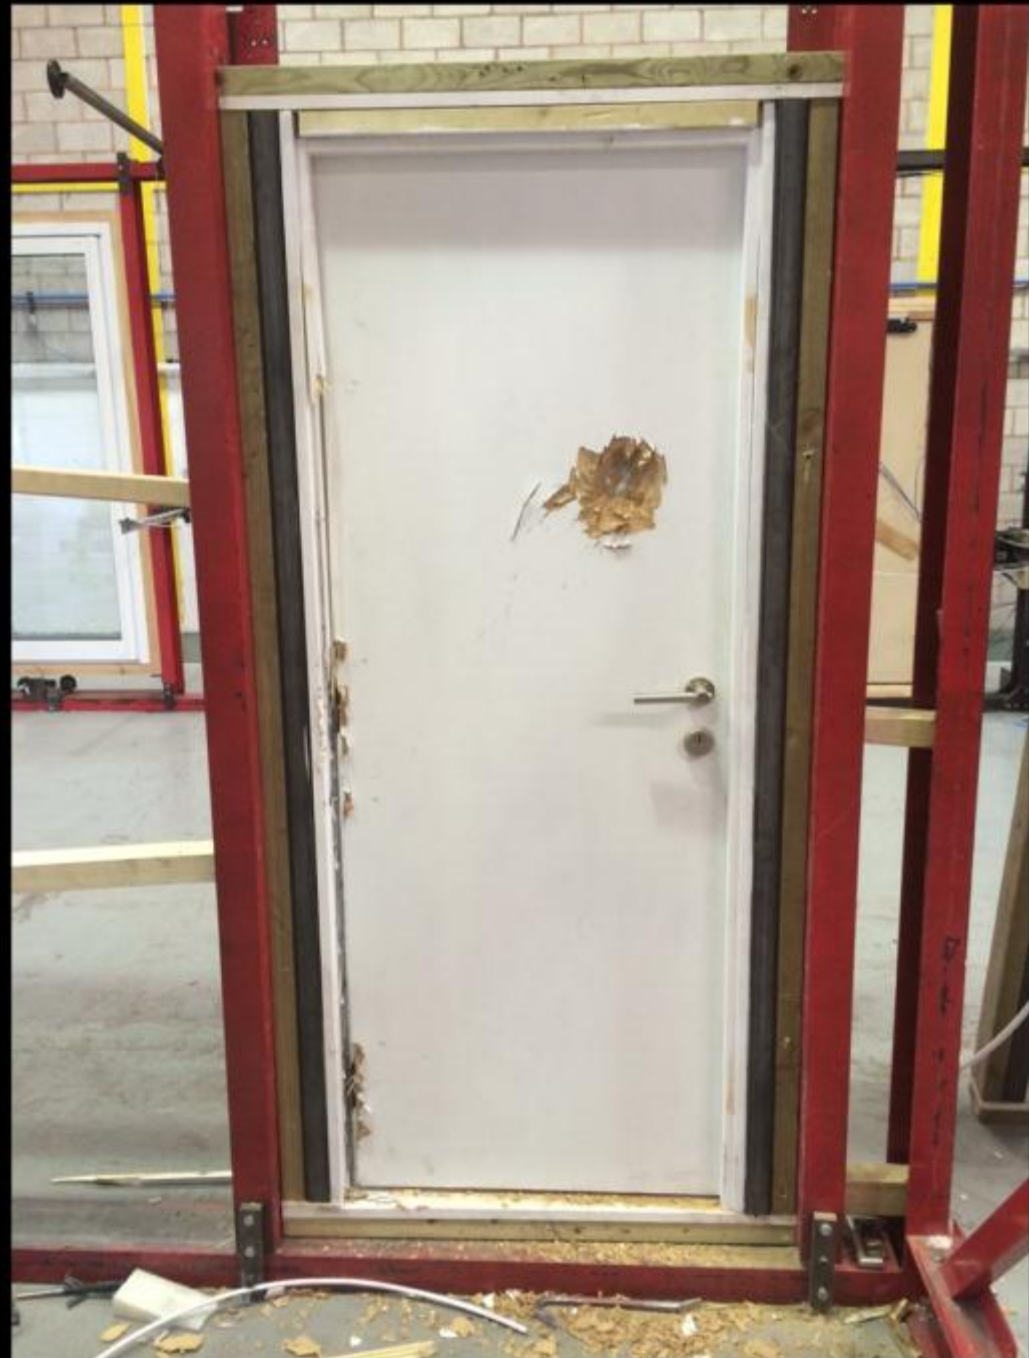
Attack To The Middle of The Door With The Use
of An 18v-Battery Powered Drill, Crowbar,
Screwdriver, Heavy Strikes From An Axe and
Heavy Downward Blows With A Large Hammer.
Attack To The Left Side of The Door Middle and
Left Side of The Door Lower Hinge With The Use
of A Crowbar

Damage To External Face and Door Frame.
NO ACCESS GAINED. PASS

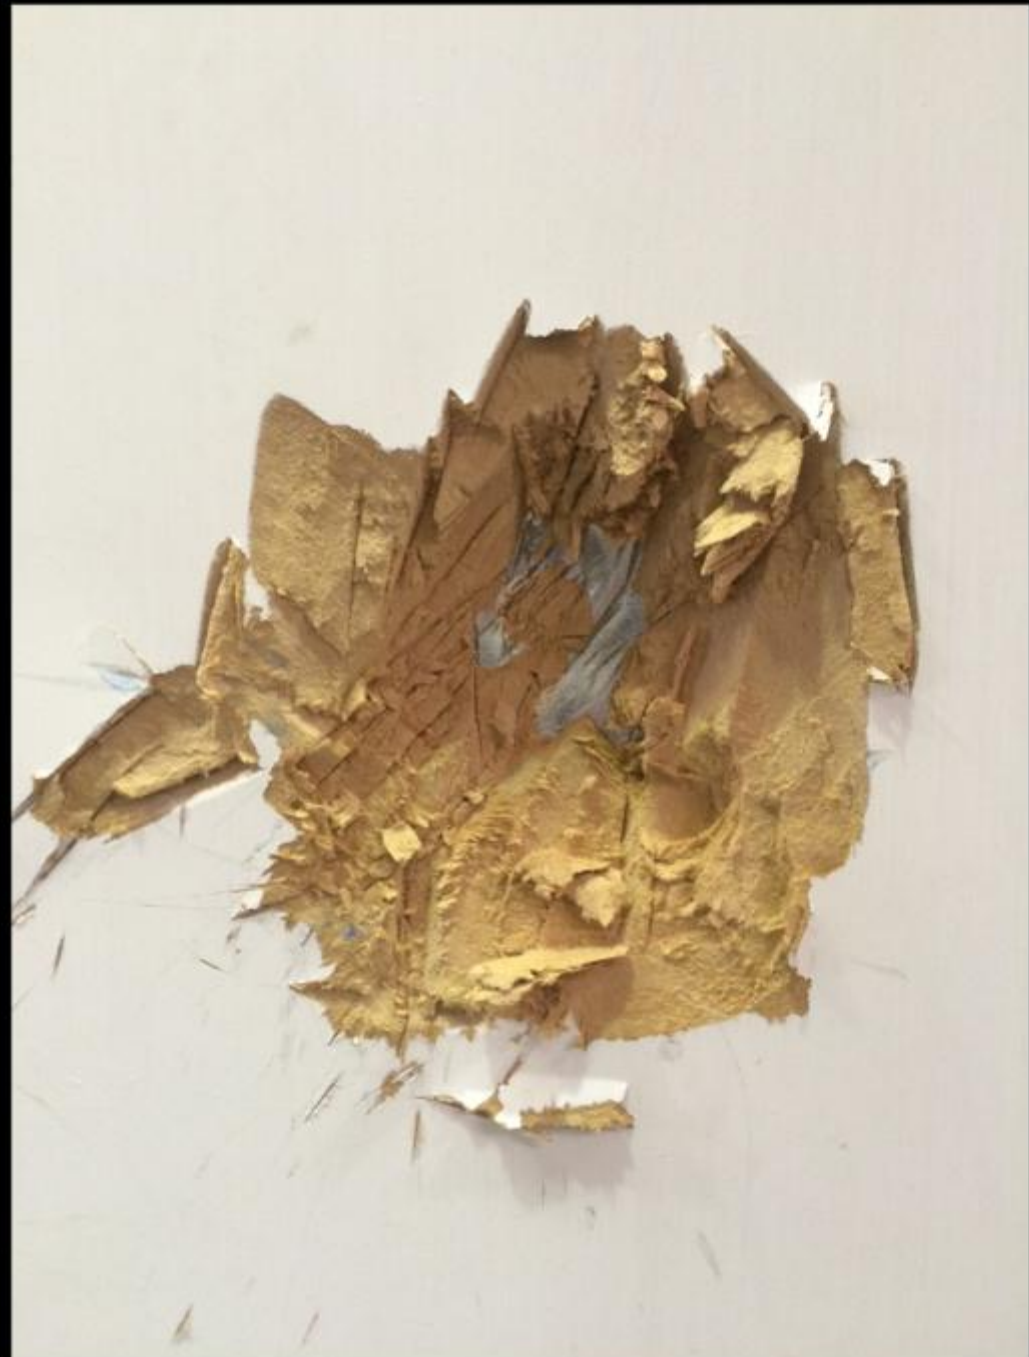
Damage To External Face.
NO ACCESS GAINED. PASS

VIEW OF ATTACK TO THE MIDDLE OF THE DOOR CLOSE UP

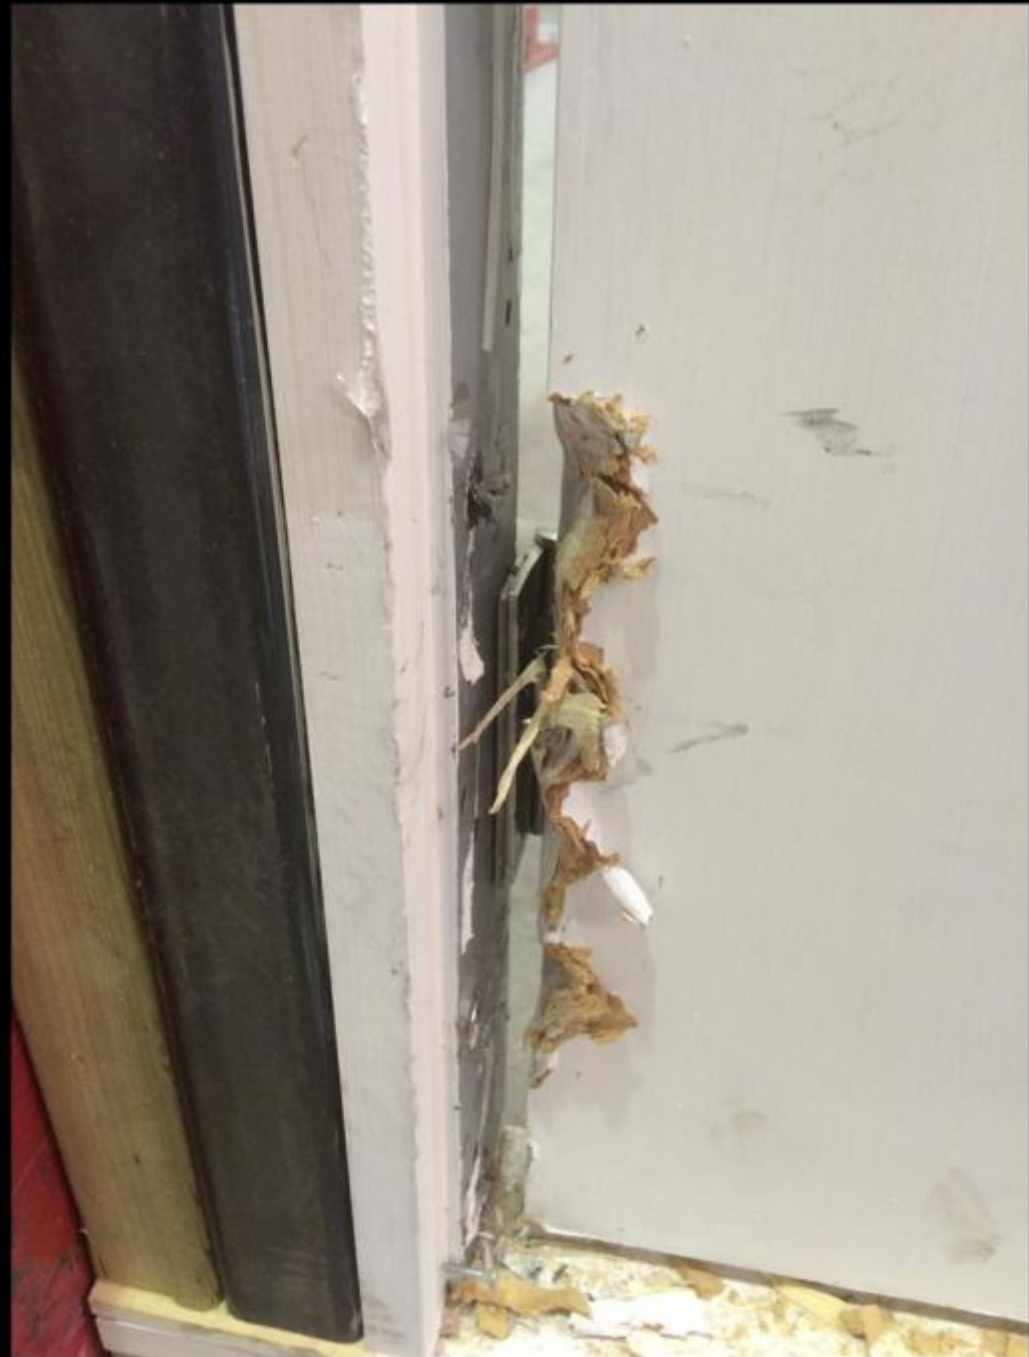
Forceful and Determined Attacks To The
Lower Hinge and Surrounding Area With
The Use of A Crowbar

Damage To External Face and Door Frame.
NO ACCESS GAINED. PASS

CLOSE UP IMAGE OF ATTACK TO HINGE AND SURROUNDING AREA

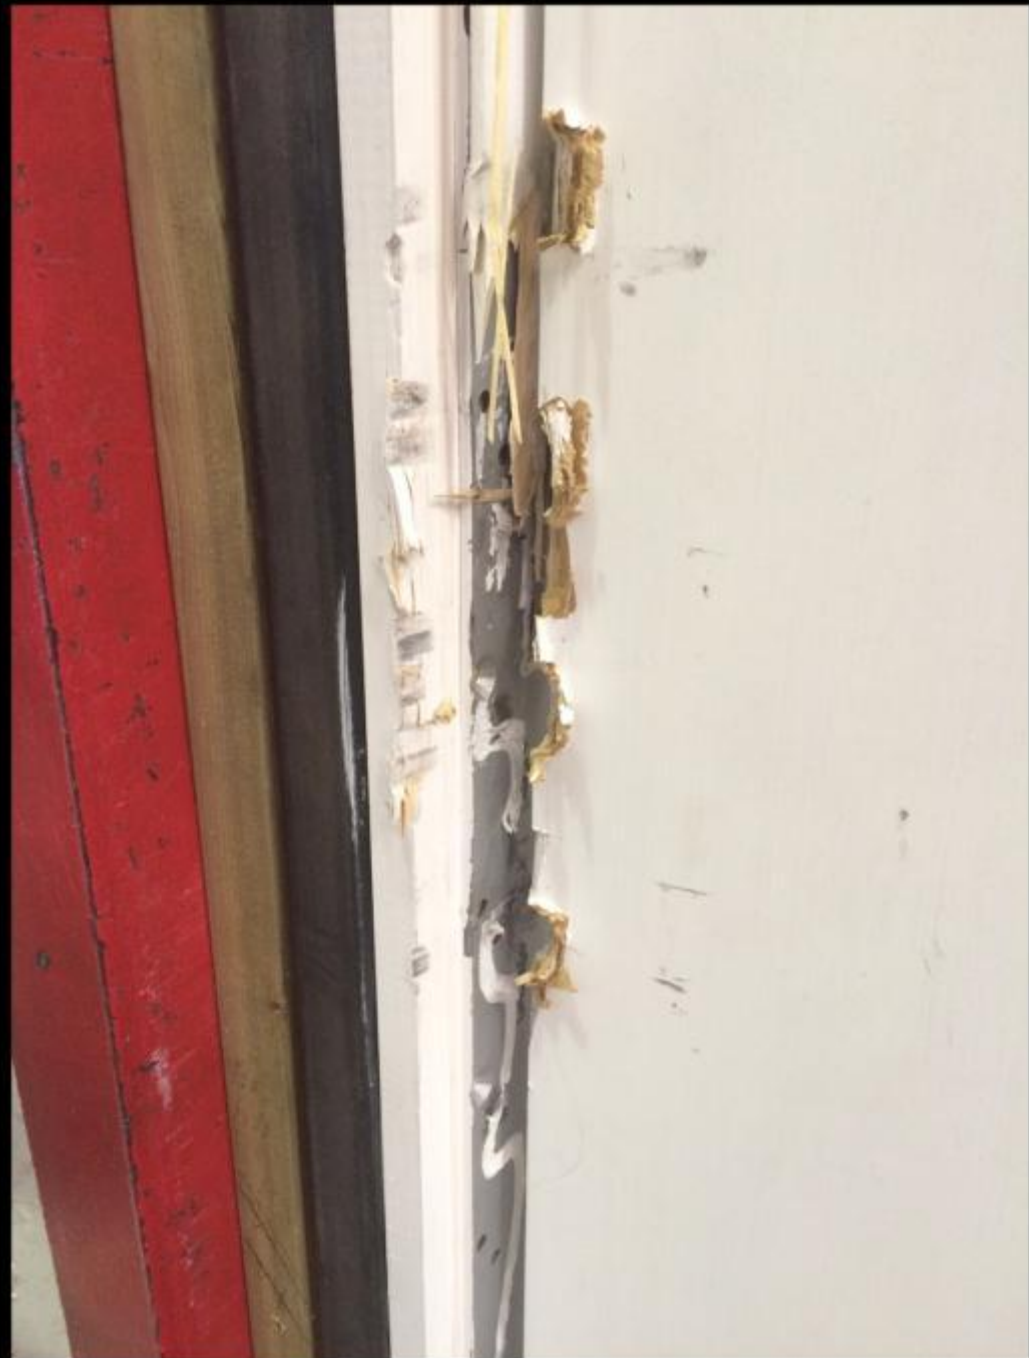
Damage To External Face and Door Frame.
NO ACCESS GAINED. PASS

CLOSE UP IMAGE
OF ATTACK TO THE MIDDLE
OF FRAME EXPOSING THE
STEEL FRAME

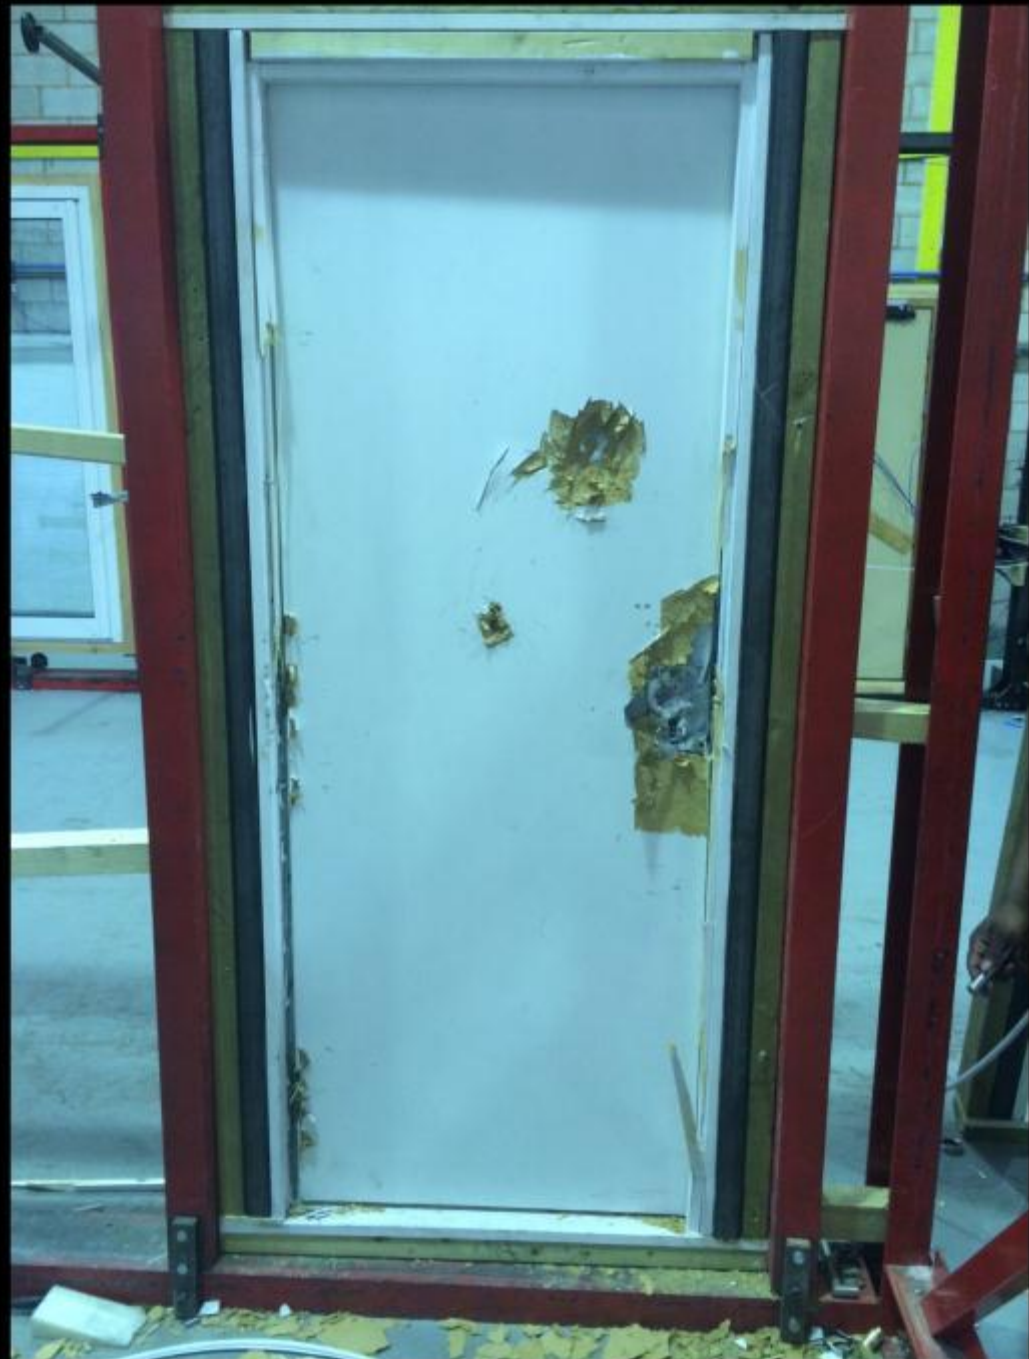
Heavy Blows To The Lock Area of The Door With The Use of The Large Hammer. Pulling and Prising Action With The Crowbar and Picking of The Lock With The Screwdriver.

Damage To External Face and Door Frame.
Minor Damage To Outer Lock Plate
NO ACCESS GAINED. PASS

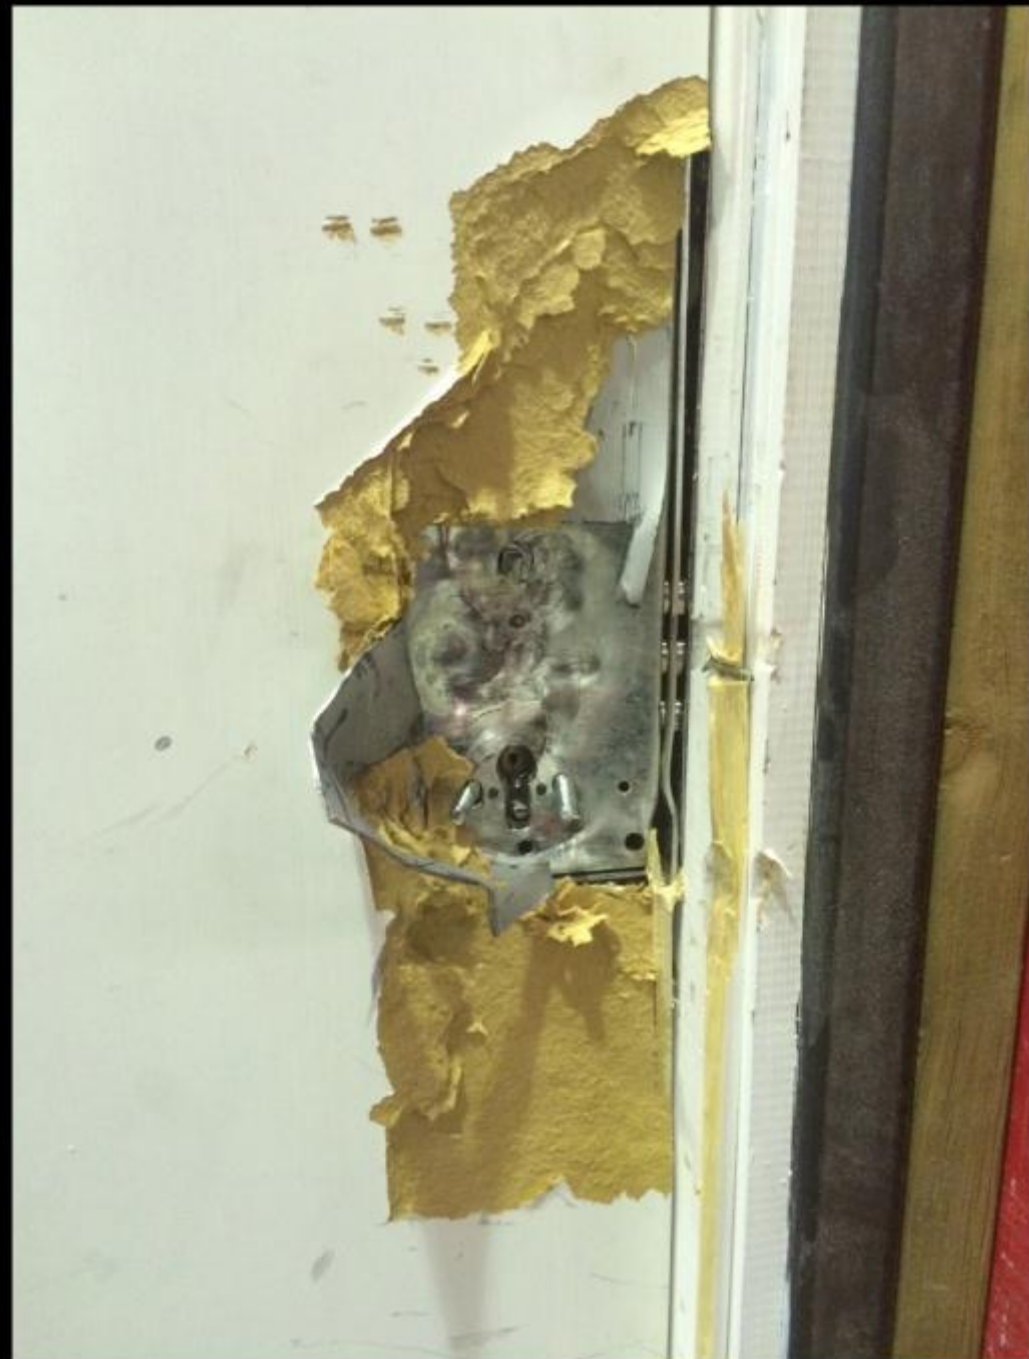
Damage To External Face and Door Frame.
Damage To Outer Lock Plate.
NO ACCESS GAINED. PASS

CLOSE UP IMAGE OF ATTACK TO LOCK REGION
